Overview: Extent of the spill incident impact on Opukushi W-34T flowline ROW. Pictures taken during Joint Investigation of 18th March, 2011

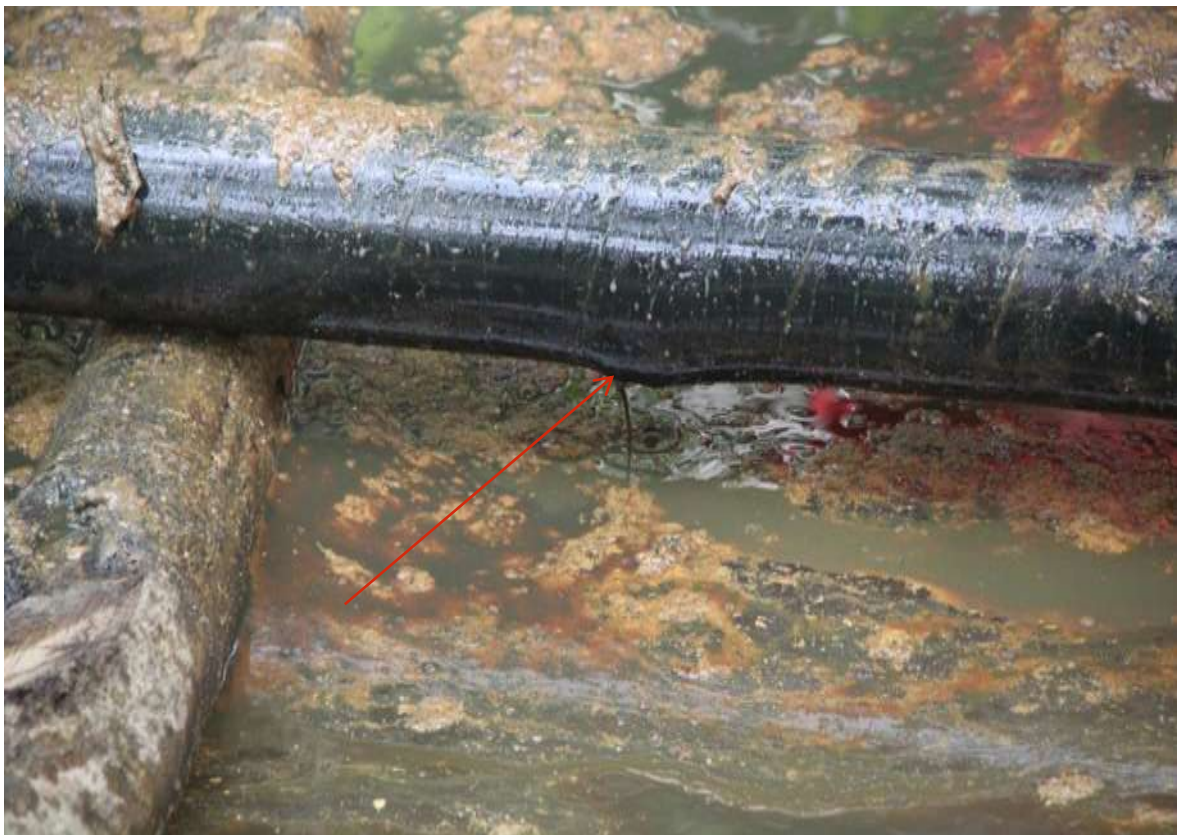
Close-up: Spill due to corrosion on Opukushi W-34T flowline ROW.. Picture taken during Joint Investigation of 18th March, 2011.
