Overview: Extent of the spill incident impact on Otumara W-44S Wellhead riser. Pictures taken during Joint Investigation of 28th March, 2011

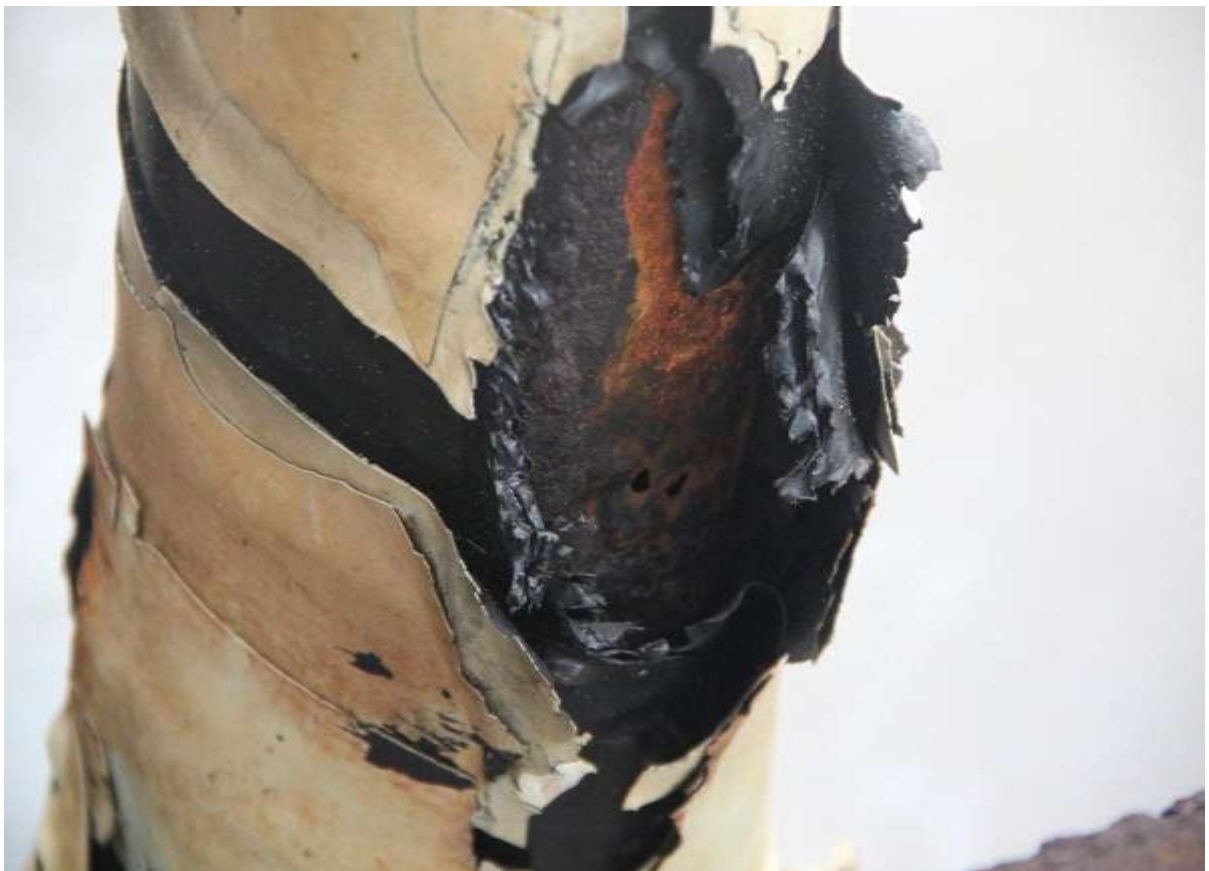
Close-up: Spill due to corrosion on Otumara W-44S Wellhead riser .Picture taken during Joint Investigation of 28th March, 2011.
