Overview: Extent of the spill incident impact on 6" Well 59T flow line at Imo River.
Pictures taken during Joint Investigation of 30th March, 2011

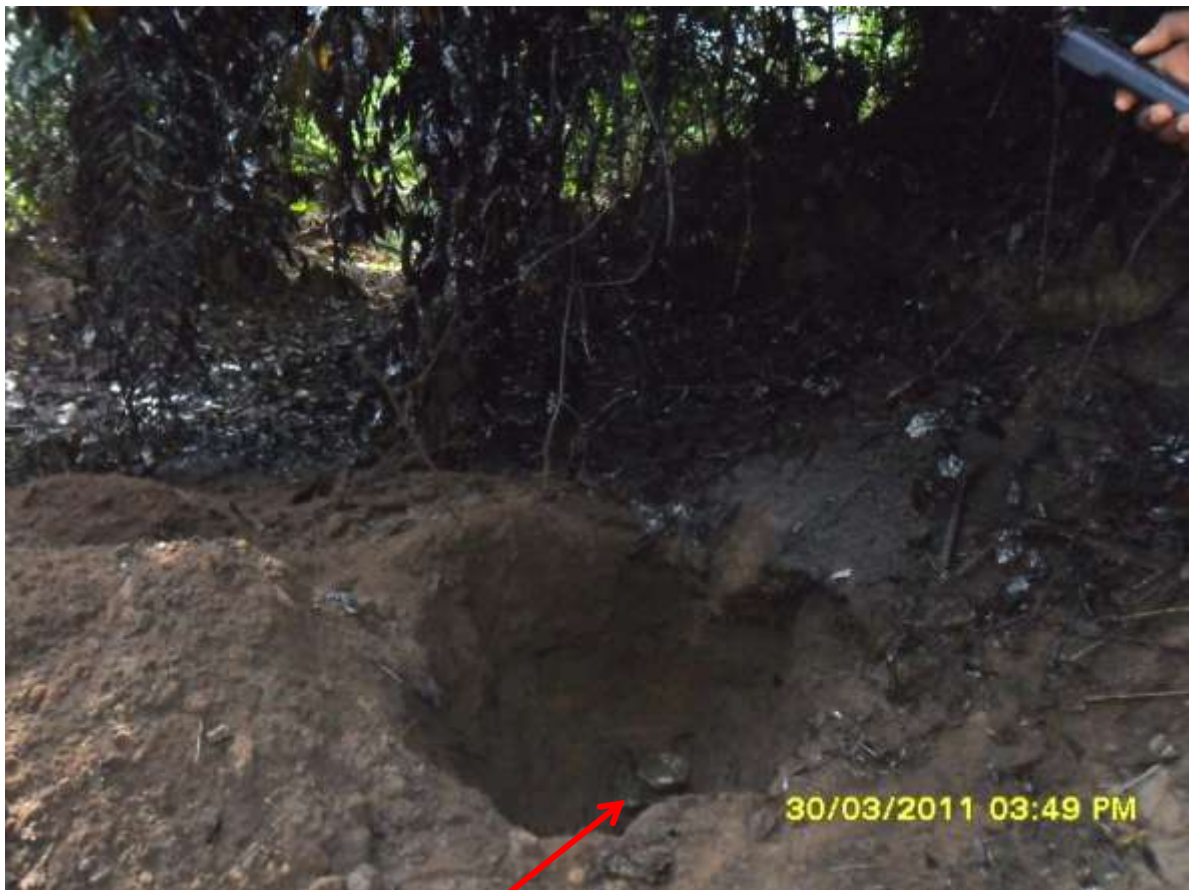
Close-up: Picture showing illegally welded point on 6" Well 59T flow line at Imo River.
Picture taken during Joint Investigation of 30th March, 2011.
