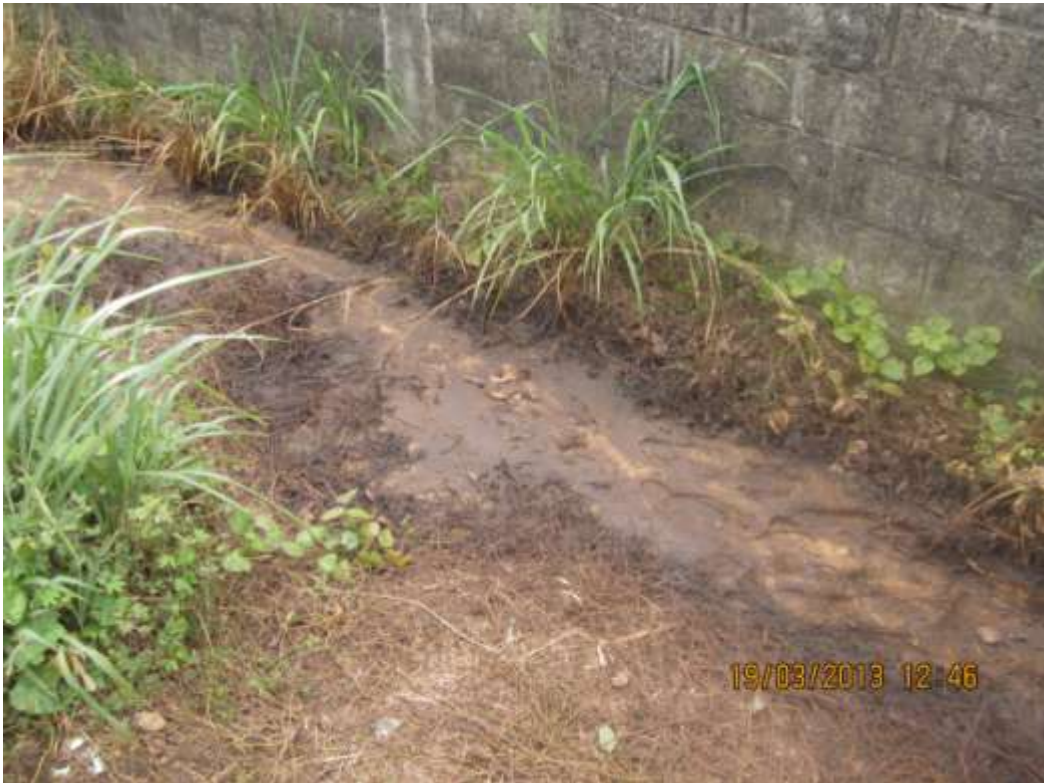
Overview: Part of spill impact on Agbada 2 Well66L flowline right of way at Umuokwa. Picture was taken during Joint Investigation of 19<sup>th</sup> March 2013.

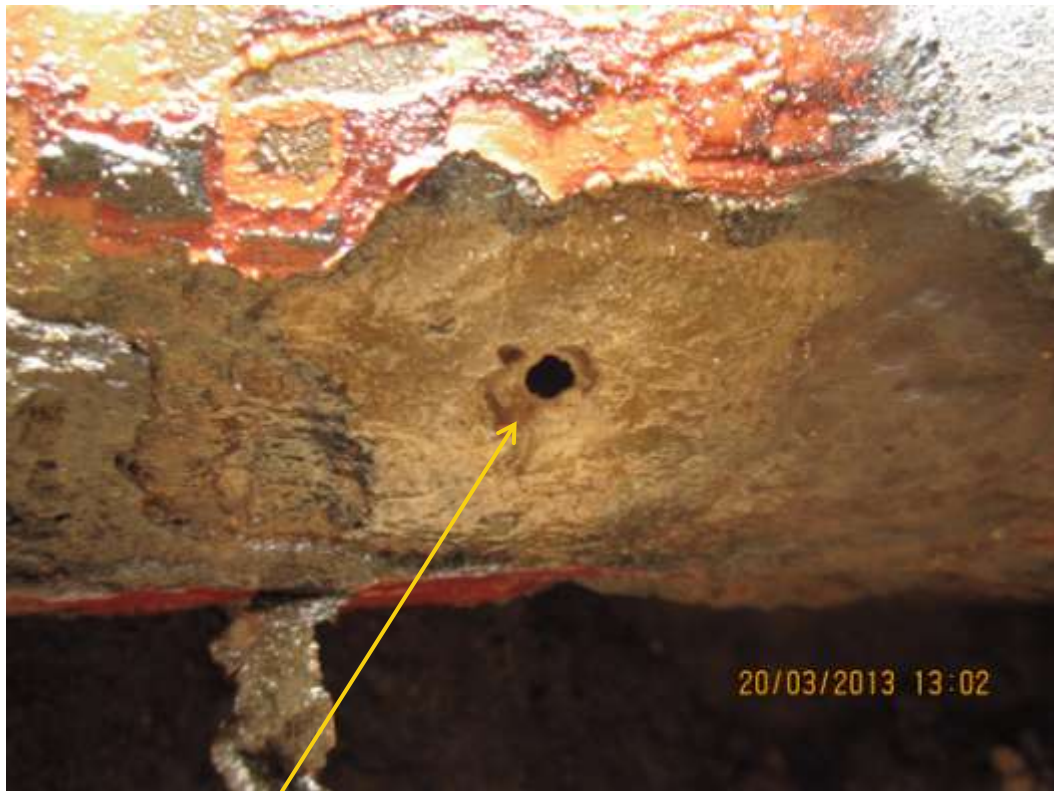
Close up: Leak due to corrosion on Agbada 2 Well66L flowline at Umuokwa. Picture was taken during Joint Investigation of 20<sup>th</sup> March 2013.
