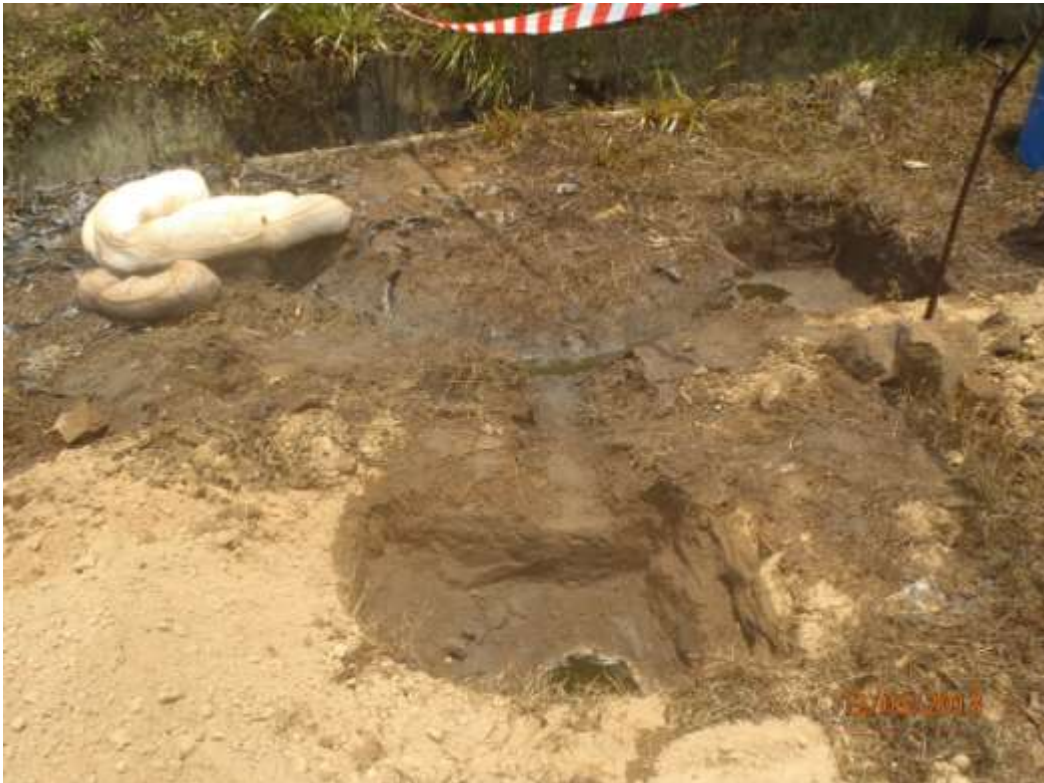
Overview: Part of spill impact on Imo River1 Well13L gaslift line right of way at Igirukwu/Isi-Etithoha. Picture was taken during Joint Investigation of 12<sup>th</sup> March 2013.

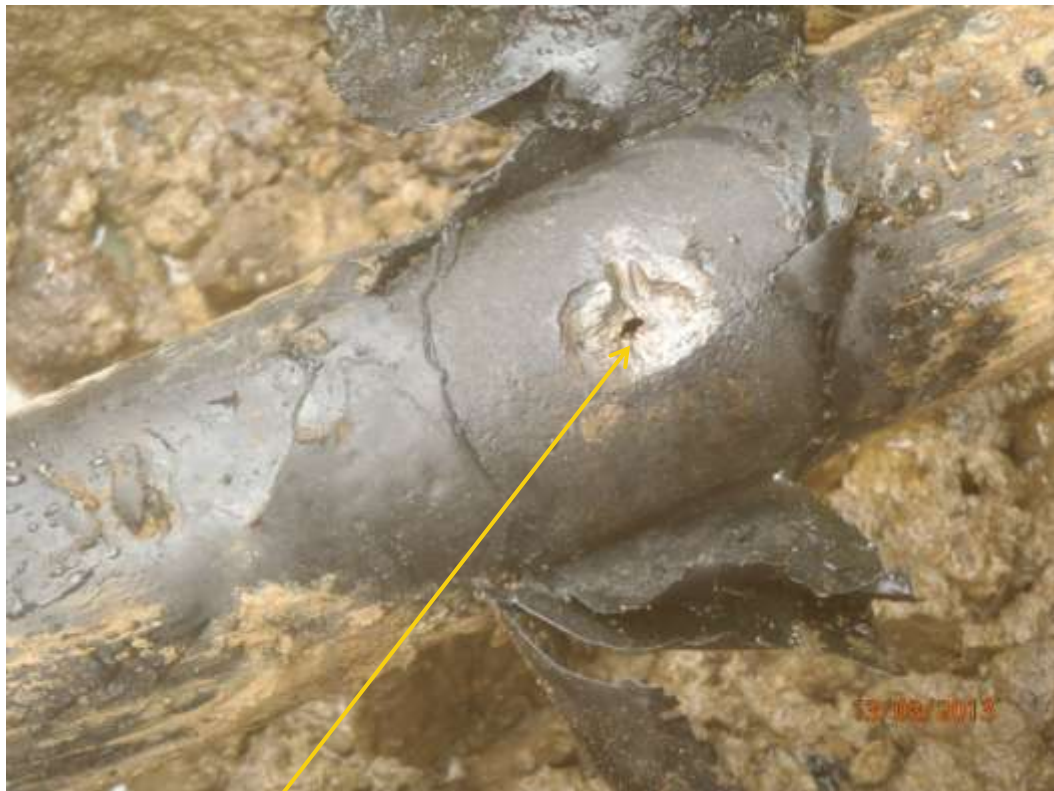
Close up: Drilled hole on Imo River1 Well13L gaslift line at Igirukwu/Isi-Etithoha. Picture was taken during Joint Investigation of 13<sup>th</sup> March 2013.
