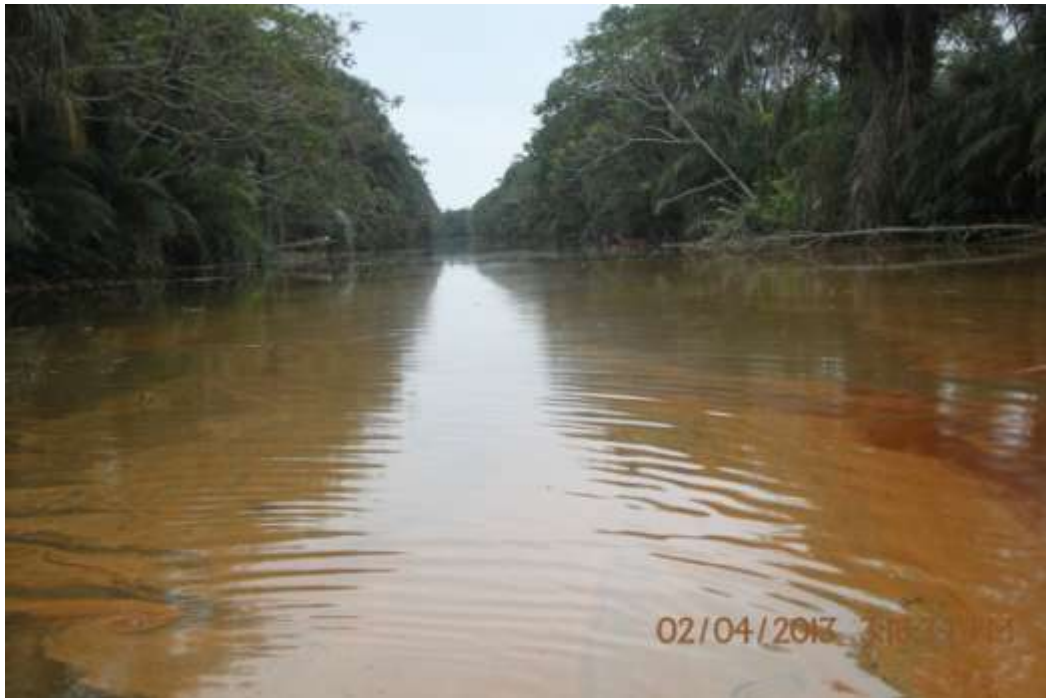
Overview: Part of spill impact on Opukushi Well34T flowline right of way at Egbemo-Angalabiri. Picture was taken during Joint Investigation of 2<sup>nd</sup> April 2013.

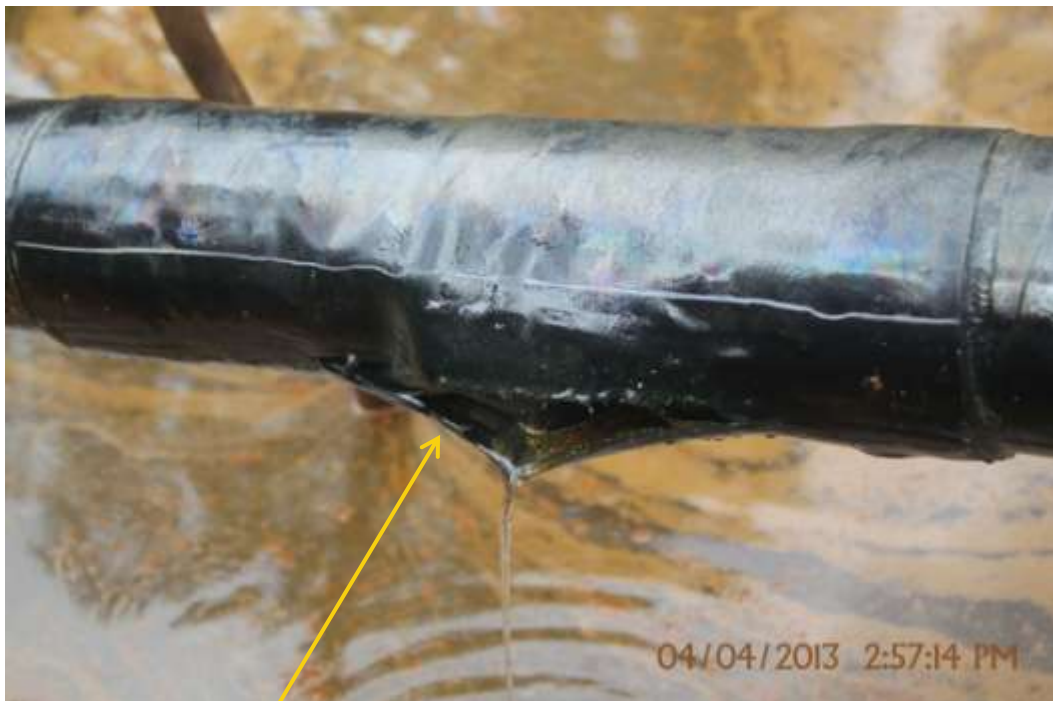
Close up: Raised pipe on Opukushi Well34T flowline at Egbemo-Angalabiri. Picture was taken during Joint Investigation of 4<sup>th</sup> April 2013.

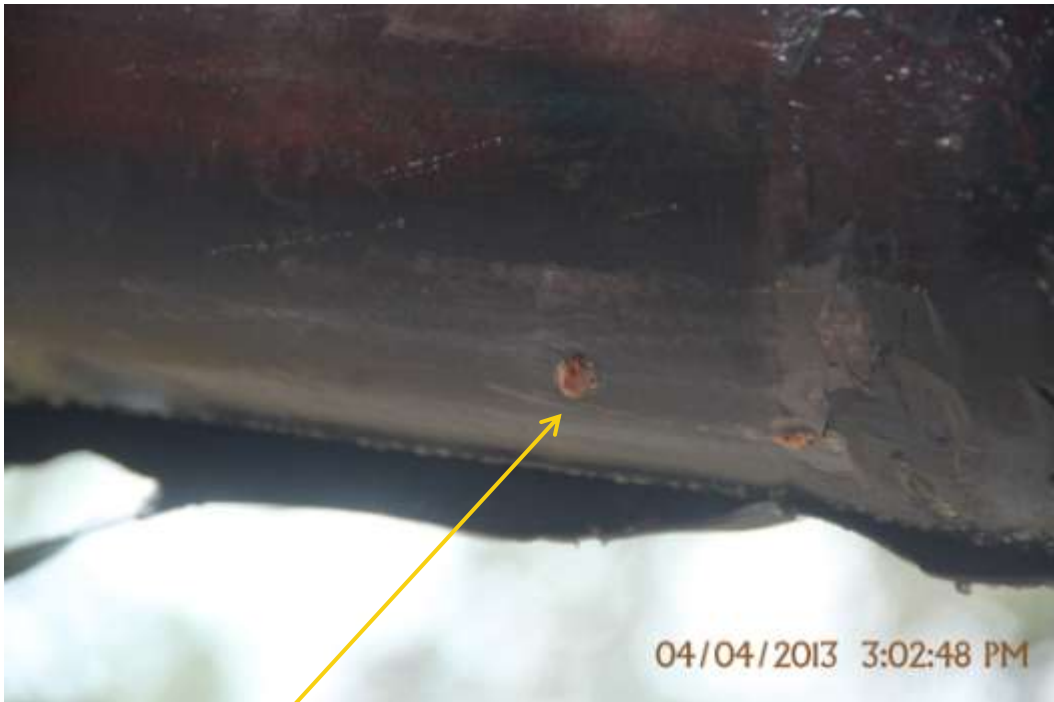
Close up: Leak due to corrosion on Opukushi Well34T flowline at Egbemo-Angalabiri. Picture was taken during Joint Investigation of 4<sup>th</sup> April 2013.
