# JOINT INVESTIGATION REPORT

INCIDENT NO: 1598133 JIV report S/N: Nº 0000149

1. Spill incident Number: 1598133 2. Type of incident\* OIL SPILL  
3. Name of Location 12" OGUTA - EGBEMA DELIVERY LINE  
4. Name of nearest community EZIORSU 5. State: IMO 6. LGA OGUTA  
7. Type of Production facility/Installation DELIVERY LINE  
8. Asset owner/District THE SHELL PETROLEUM DEVELOPMENT COMPANY OF NIGERIA

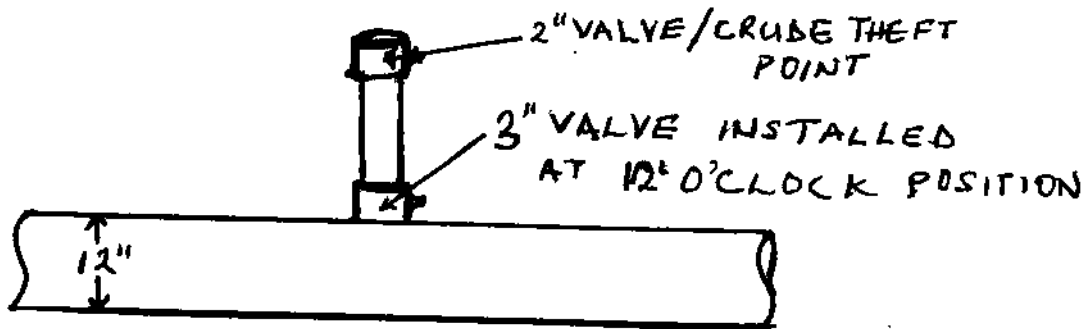
| <input checked="" type="checkbox"/> Crude oil theft (illegal bunkering) point, | <input type="checkbox"/> Saver-pit over flow | <input type="checkbox"/> Third party tampering with Clamp |

A SECTION OF 12" OGUTA - EGBEMA DELIVERY LINE SHOWING 3" VALVE INSTALLED AT 12 O'CLOCK POSITION BY UNKNOWN PERSONS (CRUDE THEFT POINT)

LEAK REPAIR COMMENCED
