# JOINT INVESTIGATION REPORT

INCIDENT NO: 1826836 JIV report S/N: Nº 0000235

1. Spill incident Number: 1826836 2. Type of incident\* OIL SPILL  
3. Name of Location 12" IMD RIVER - OGALE PIPELINE  
4. Name of nearest community UZUAKU 5. State: ABIA 6. LGA UKWA WEST  
7. Type of Production facility/Installation OIL PIPELINE  
8. Asset owner/District THE SHELL PETROLEUM DEVELOPMENT COMPANY OF NIGERIA LTD (SPDC)/PIPELINE

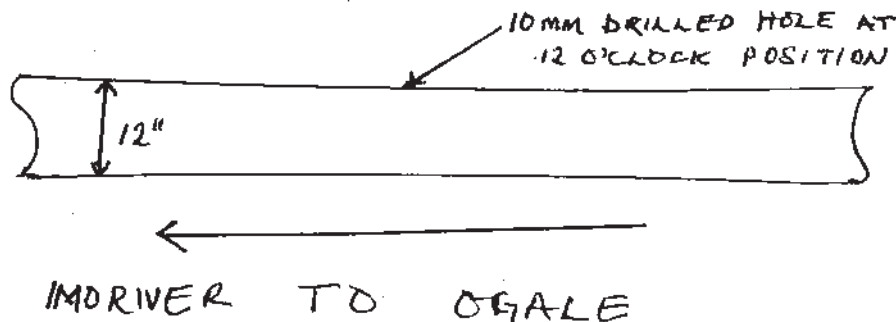
Additional observations around the spill point: THE TEAM OBSERVED A DRILLED HOLE AT 12 O'CLOCK POSITION.

A SECTION OF 12" IMORIVER - OGALE PIPELINE AT UZUAKU SHOWING A 10MM DRILLED HOLE AT 12 O'CLOCK POSITION DONE BY UNKNOWN PERSONS.

REPAIR BY CLAMPING
