# JOINT INVESTIGATION REPORT

INCIDENT NO: 2043005 JIV report S/N: 1025

1. Spill incident Number: 2043005 2. Type of incident\* OIL SPILL  
3. Name of Location 16" EGBEMA - ASSA PIPELINE  
4. Name of nearest community OBILE 5. State: IMO 6. LGA OHAJI-EGBEMA  
7. Type of Production facility/Installation OIL PIPELINE  
8. Asset owner/District THE SHELL PETROLEUM DEVELOPMENT COMPANY OF NIGERIA LTD (SPDC) / PIPELINE

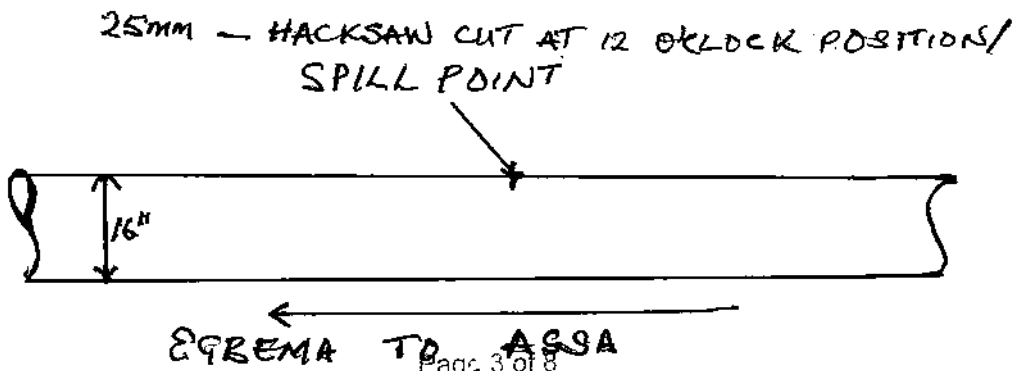
Additional observations around the spill point: THE TEAM OBSERVED HACKSAW CUT AT 12'O'CLOCK POSITION

**E. GRAPHIC DESCRIPTION OF LEAK POINT** (While detail report of the leak point should be contained in the leak report, overview sketch of the site should be added as an appendix I) A SECTION 16" EGREMA

- ASSA PIPELINE AT DRILE SHOWING A 25MM HACKSAW CUT AT 12 O'CLOCK POSITION BY UNKNOWN PERSONS.
