JOINT INVESTIGATION REPORT

INCIDENT NO: 2038808 JIV report S/N: 1023

1. Spill incident Number: 2038808 2. Type of incident* OIL SPILL
3. Name of Location 28" BOMU - BONNY PIPELINE
4. Name of nearest community AYAMBO-BONNY 5. State: RIVERS 6. LGA BONNY
7. Type of Production facility/Installation OIL PIPELINE
8. Asset owner/District THE SHELL PETROLEUM DEVELOPMENT COMPANY OF NIGERIA LIMITED/PIPELINE

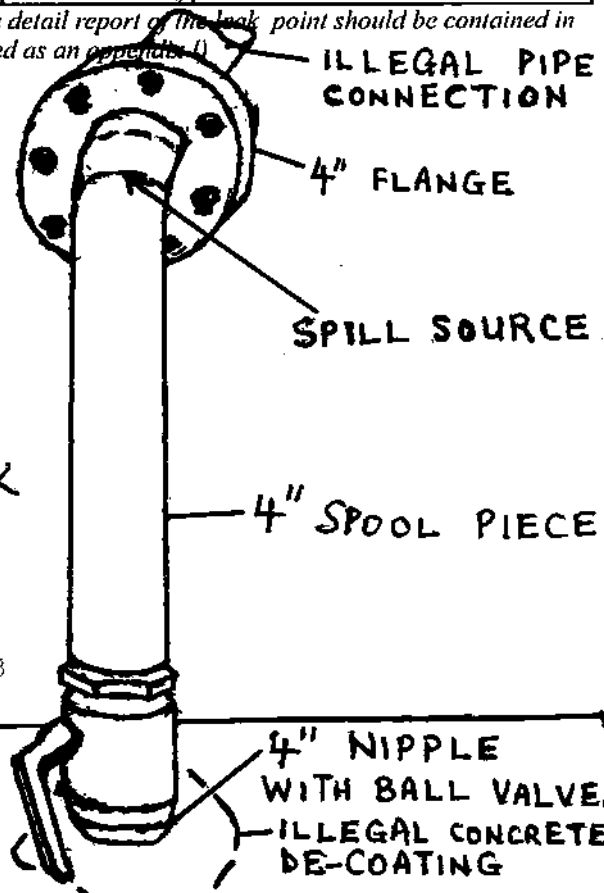
Additional observations around the spill point: UPON ARRIVAL AT SITE, THE JOINT INVESTIGATION TEAM OBSERVED THAT A BUND WALL, SERVING AS A CONTAINMENT MEASURE, HAD BEEN CONSTRUCTED AROUND THE SPILL POINT. UPON EXPOSURE OF THE SPILL POINT, A SECTION OF THE PIPELINE CONCRETE COATING SURROUNDING IT WAS OBSERVED TO HAVE BEEN REMOVED BY UNKNOWN PERSON(S).

SECTION OF 28"
BOMU - BONNY PIPELINE
AT AYAMBO - BONNY
SHOWING ONE (1) NO. 4"
CRUDE OIL THEFT POINT
INSTALLED AT 12 O' CLOCK
POSITION BY UNKNOWN
PERSON(S).
