JOINT INVESTIGATION REPORT

INCIDENT NO: 2600329 JIV report S/N:0281

1. Spill incident Number: 2600329 2. Type of incident*: OIL SPILL
3. Name of Location 28" NKPOKU - EBUBU PIPELINE
4. Name of nearest community RUMUOWHA
ENEKA 5. State: RIVERS 6. LGA OBIO/AKPOR
7. Type of Production facility/Installation OIL PIPELINE
8. Asset owner/District THE SHELL PETROLEUM DEVELOPMENT COMPANY OF NIGERIA LTD (SPDC) / PIPELINE

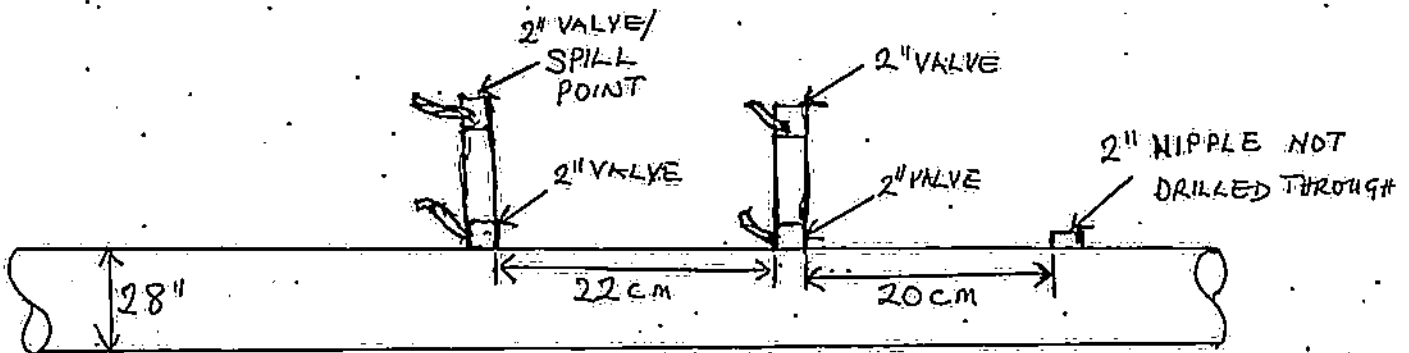
E. GRAPHIC DESCRIPTION OF LEAK POINT (while detailed report of the leak point should be contained in the leak report, overview sketch of the site should be added as an appendix 1) A SECTION OF 28" NKPOKU-EBUBU PIPELINE AT RUMURWA ENKA SHOWING 2" VALVE CRUDE OIL THEFT POINTS 22CM APART, INSTALLED AT 12 O'CLOCK POSITIONS BY UNKNOWN PERSONS.

← NKPOKU TO EBUBU →

REPAIR BY CLAMPING
