JOINT INVESTIGATION REPORT

INCIDENT NO 2614095 JIV report S/N 0478

1. Fountain Incident Number 2614095 2. Type of incident* OIL SPILL
 3. Name of location NUM RIVER WELL 13E WELL HEAD
 4. Name of nearest community ANGIANA State BAYELSA Local Government Area SOUTHERN ISLAND
 7. Production Facility Installation WELL HEAD
 8. Asset Owner Hub THE SHELL PETROLEUM DEVELOPMENT (NIGERIA) LIMITED / CENTRAL HUBS OF NIGERIA LIMITED / CENTRAL HUBS

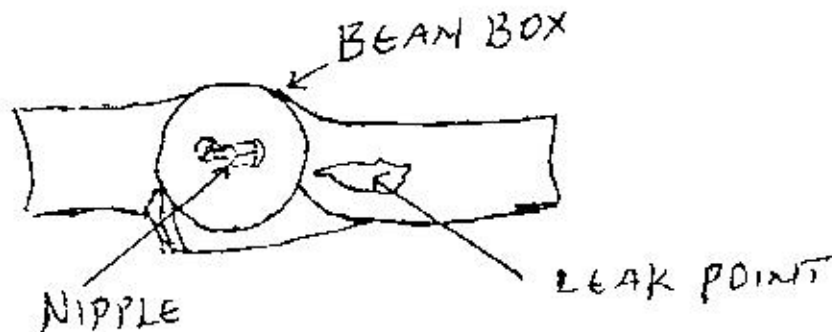
Tear (_____)
 Others (specify) EROSION OF BEAN BOX

SECTION OF NUN RIVER WELL 137 WELL HEAD AT ANGIAMA SHOWING POSITION OF EROSION OF BEAM BOX.
