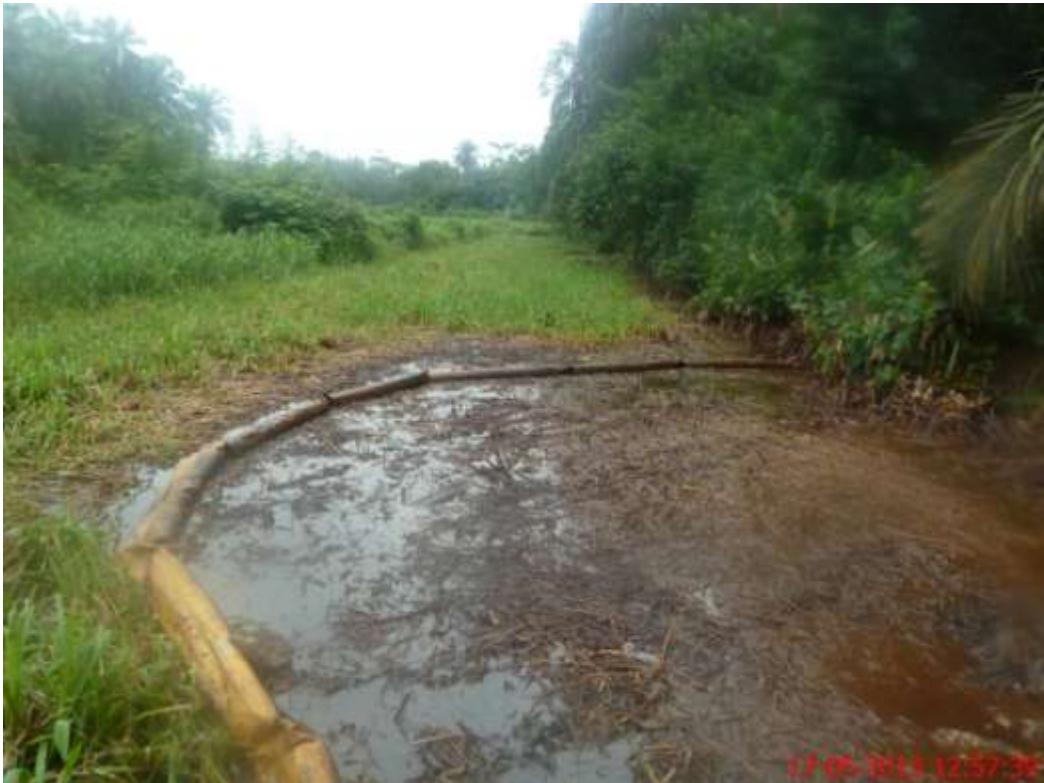
Overview: Part of spill impact on Well20T 6" flowline right of way at Otusega. Picture was taken during Joint Investigation of 17th May 2013.

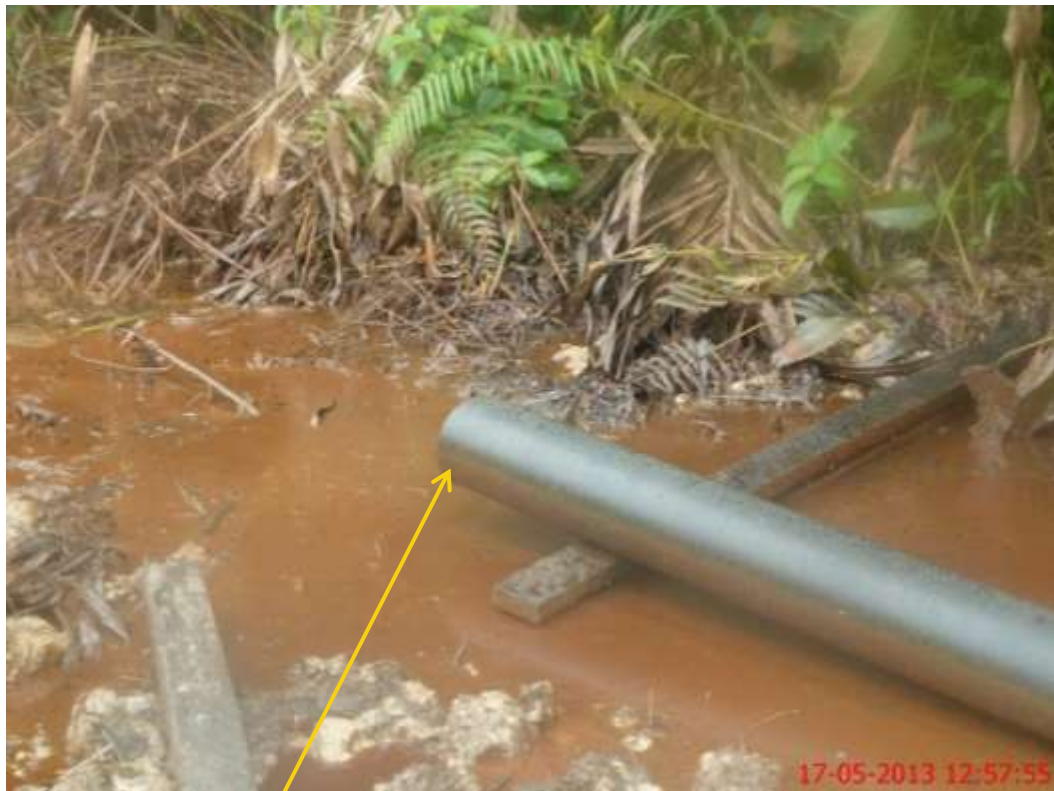
Close up: Cut section of Well20T 6" flowline at Otusega. Picture was taken during Joint Investigation of 17th May 2013.
