# JOINT INVESTIGATION REPORT

INCIDENT NO: 00005/397816 JIV report S/N:

1. Spill incident Number: 1397816 2. Type of incident\* OIL SPILL  
3. Name of Location 10" DIEBU CREEK - NUN RIVER PIPELINE  
4. Name of nearest community OPOROMA 5. State: BAYELSA 6. LGA SOUTHERN ITAW  
7. Type of Production facility/Installation OIL PIPELINE  
8. Asset owner/District THE SHELL PETROLEUM DEVELOPMENT COMPANY OF NIGERIA LIMITED/PIPELINE

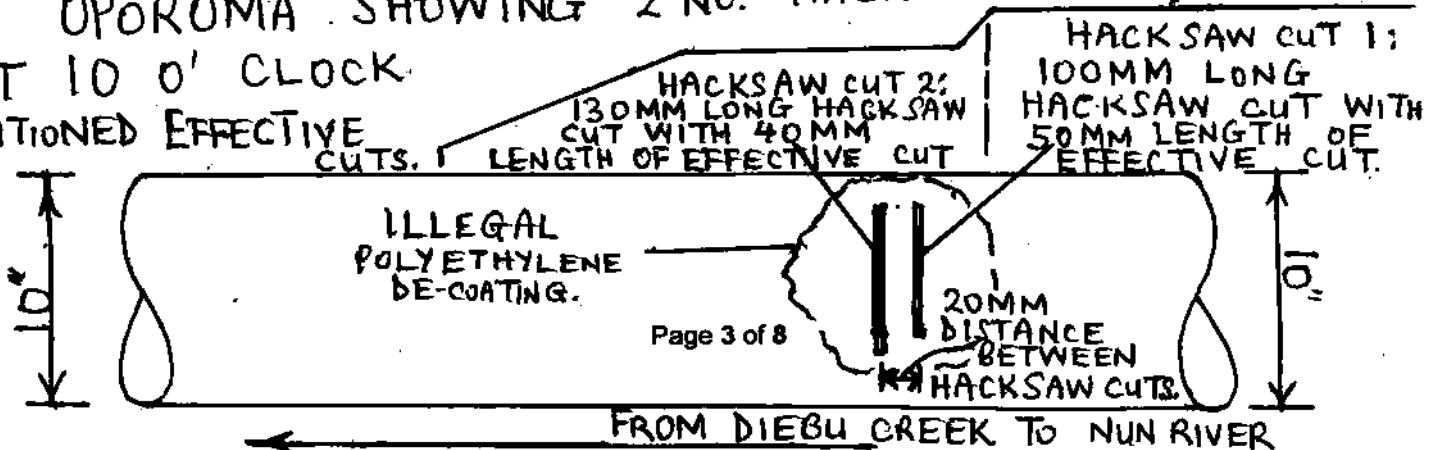
Additional observations around the spill point: ON EXPOSURE OF AFFECTED PIPELINE SECTION BY THE JOINT INVESTIGATION TEAM, THE PIPELINE POLYETHYLENE COATING AROUND TWO NO. OBSERVED HACK SAW CUTS (LEAK POINTS) WAS NOTICED TO HAVE BEEN REMOVED BY UNKNOWN PERSON(S), IMPACTED SOIL ON SITE IS LIGHT BROWN MARSHY SILTY CLAY.

SECTION OF 10" DIEBU CREEK - NUN RIVER PIPELINE AT OPOROMA SHOWING 2 NO. HACKSAW CUTS, AT 10 O' CLOCK.

POSITIONED EFFECTIVE CUTS.

RECOVERY OF FREE-PHASE OIL WAS DONE WHILE REPAIRS WERE EFFECTED ON THE AFFECTED SECTION OF PIPELINE BY CLAMPING.
