JOINT INVESTIGATION REPORT

INCIDENT NO: 1408364 JIV report S/N: Nº 0000003

1. Spill incident Number: 1408364 2. Type of incident* OIL SPILL AND FIRE
3. Name of Location 28" Nkpoku - Boma Pipeline
4. Name of nearest community KPOGHOR AND GIO 5. State: RIVERS 6. LGA TAI
7. Type of Production facility/Installation OIL PIPELINE
8. Asset owner/District SPDC / PIPELINE

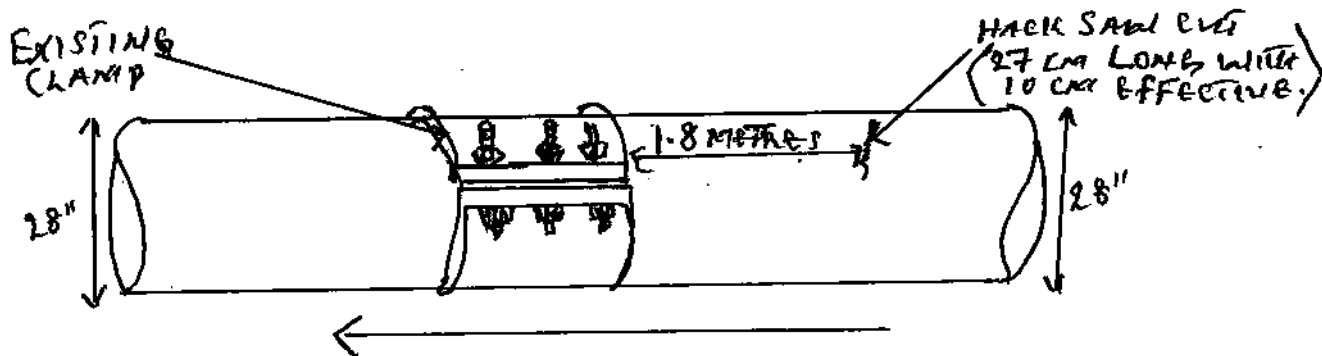
Additional observations around the spill point: DURING THE JOINT INVESTIGATION VISIT, THE TEAM NOTICED THAT EFFECTIVE PART OF HACK SAW CUT WAS PLUGGED.

SECTION OF 28" NKPOKU - BOMU PIPELINE ASKPOGHOH AND GIO SHOWING G HAZK SAW CUT AT 1 O'CLOCK POSITION.

FROM NKPOKU TO BOMU.

RECOVERY ACTIVITIES ONGOING.
REPAIR WORK WAS DONE BY CHIPPING.
