JOINT INVESTIGATION REPORT

INCIDENT NO: 1628051 JIV report S/N: Nº 0000159

1. Spill incident Number: 1628051 2. Type of incident* OIL SPILL
3. Name of Location IBAA MANIFOLD 8" HEADER.
4. Name of nearest community IBAA 5. State: RIVERS 6. LGA EMOTHUA.
7. Type of Production facility/Installation MANIFOLD
8. Asset owner/District THE SHELL PETROLEUM DEVELOPMENT COMPANY OF NIGERIA LIMITED.

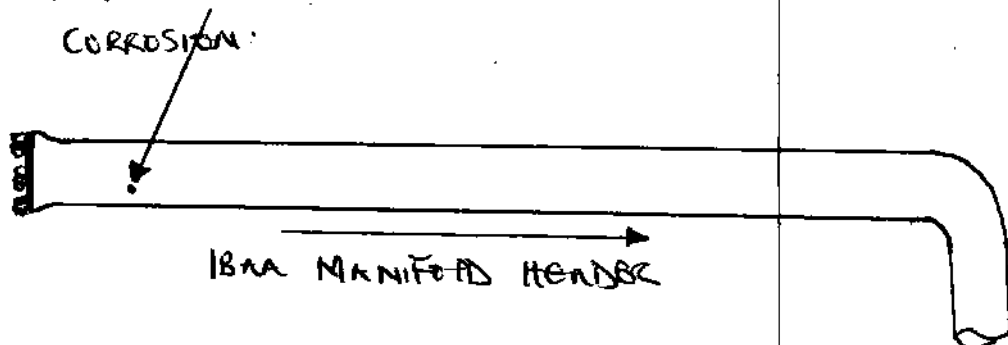
SECTIONAL VIEW OF IBAA MANIFOLD 8" HEADER AT IBAA, SHOWING
LEAK DUE TO (INTERNAL) CORROSION WITH 5mm RUPTURE.

LEAK IS DUE TO 5mm DIAMETER
RUPTURE CAUSE BY (INTERNAL)
CORROSION:
