# JOINT INVESTIGATION REPORT

INCIDENT NO: 1863621 JIV report S/N:

1. Spill incident Number: 1863621 2. Type of incident\* OIL SPILL  
3. Name of Location 12" IMO RIVER - OGAE PIPELINE  
4. Name of nearest community LUZUAKU 5. State: ABIA 6. LGA LIKWA WEST  
7. Type of Production facility/Installation OIL PIPELINE  
8. Asset owner/District THE SHELL PETROLEUM DEVELOPMENT COMPANY OF NIGERIA LTD  
(SPDC)

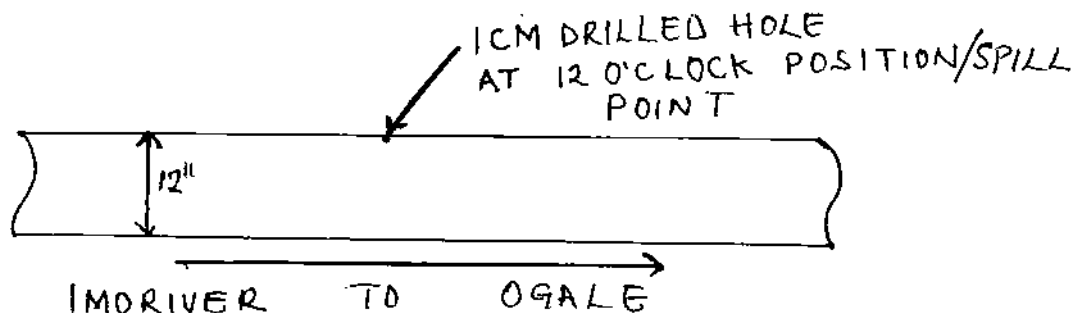
Additional observations around the spill point: THE JOINT INVESTIGATION TEAM SAW A DRILLED HOLE AT 12 O'CLOCK POSITION.

**E. GRAPHIC DESCRIPTION OF LEAK POINT** (while detail report of the leak point should be contained in the leak report, overview sketch of the site should be added as an appendix 1) A SECTION OF 12" IMORIVER - OGALE PIPELINE AT UZUAKU SHOWING A 1cm DRILLED HOLE AT 12 O'CLOCK POSITION BY UNKNOWN PERSONS.

REPAIR BY CLAMPING
