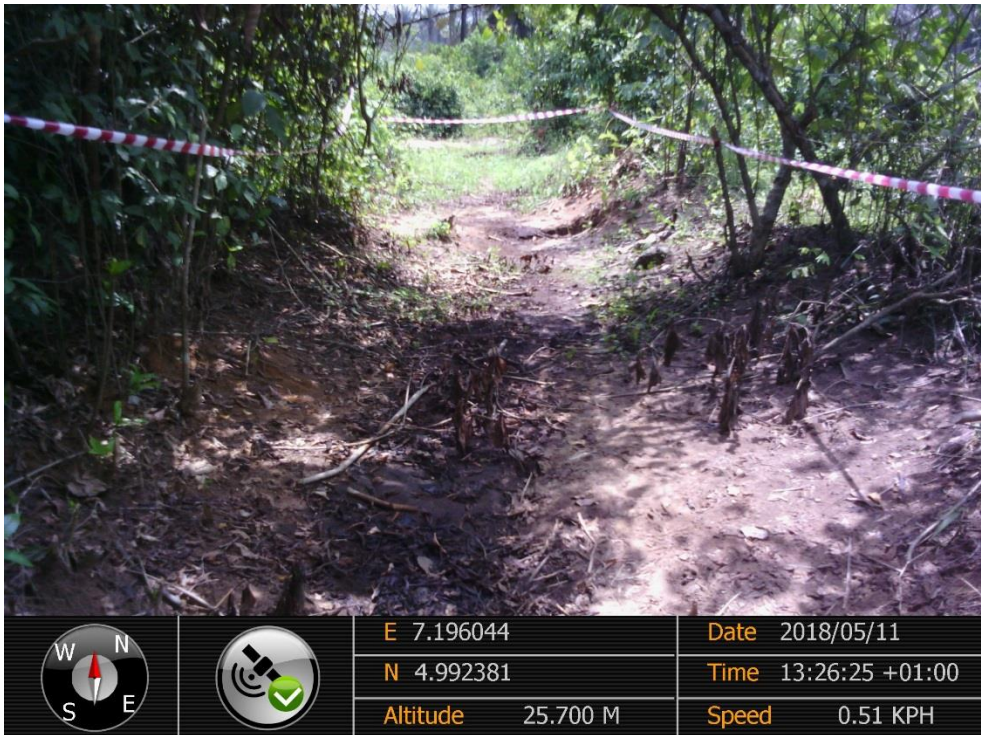
**Overview:** Part of spill impact on 6" Imo River Well 59T Flowline at Igiriukwu\_Owaza. Picture was taken during Joint Investigation of 11<sup>th</sup> May 2018.

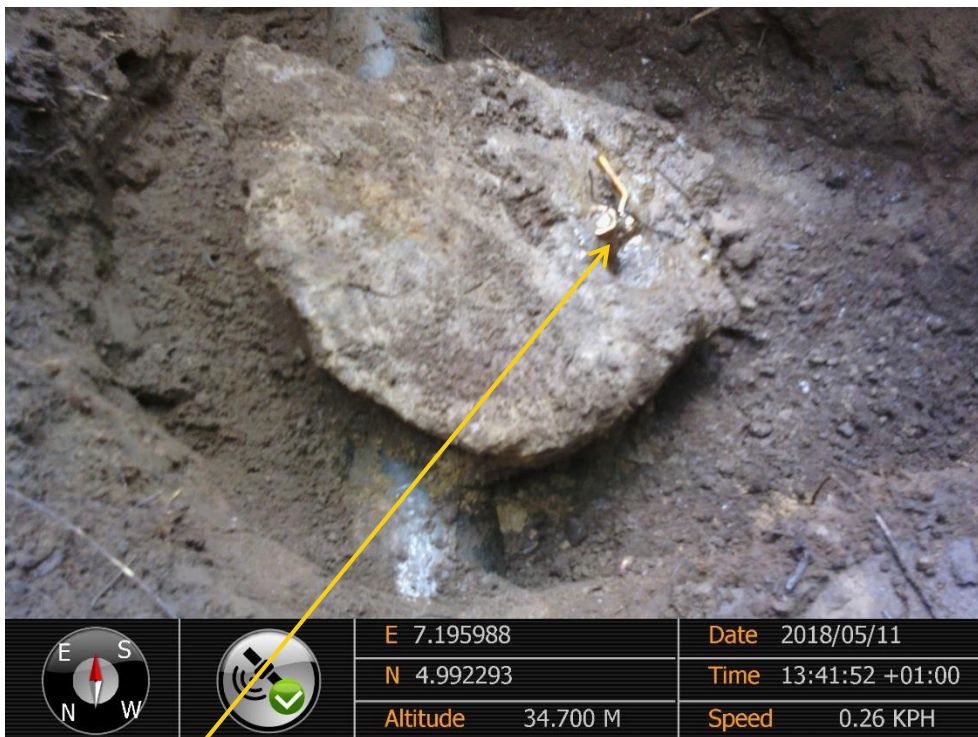
**Close-up:** Illegal fitting partly concealed in cast concrete on 6" Imo River Well 59T Flowline at Igiriukwu\_Owaza. Picture was taken during Joint Investigation of 11<sup>th</sup> May 2018.
