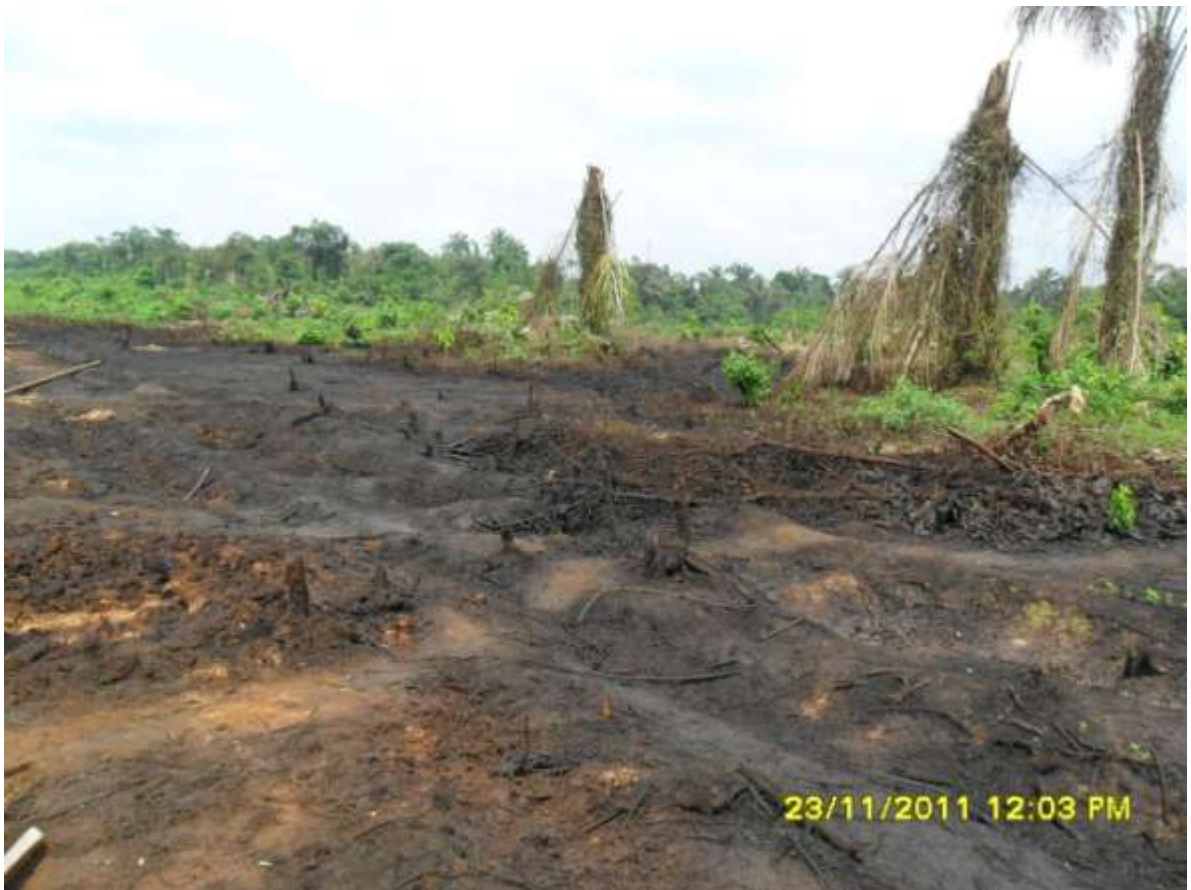
Overview: Part of spill impact on 12" ImoRiver2-Ebubu pipeline right of way at Odagwa. Picture was taken during Joint Investigation of 23<sup>rd</sup> November, 2011.

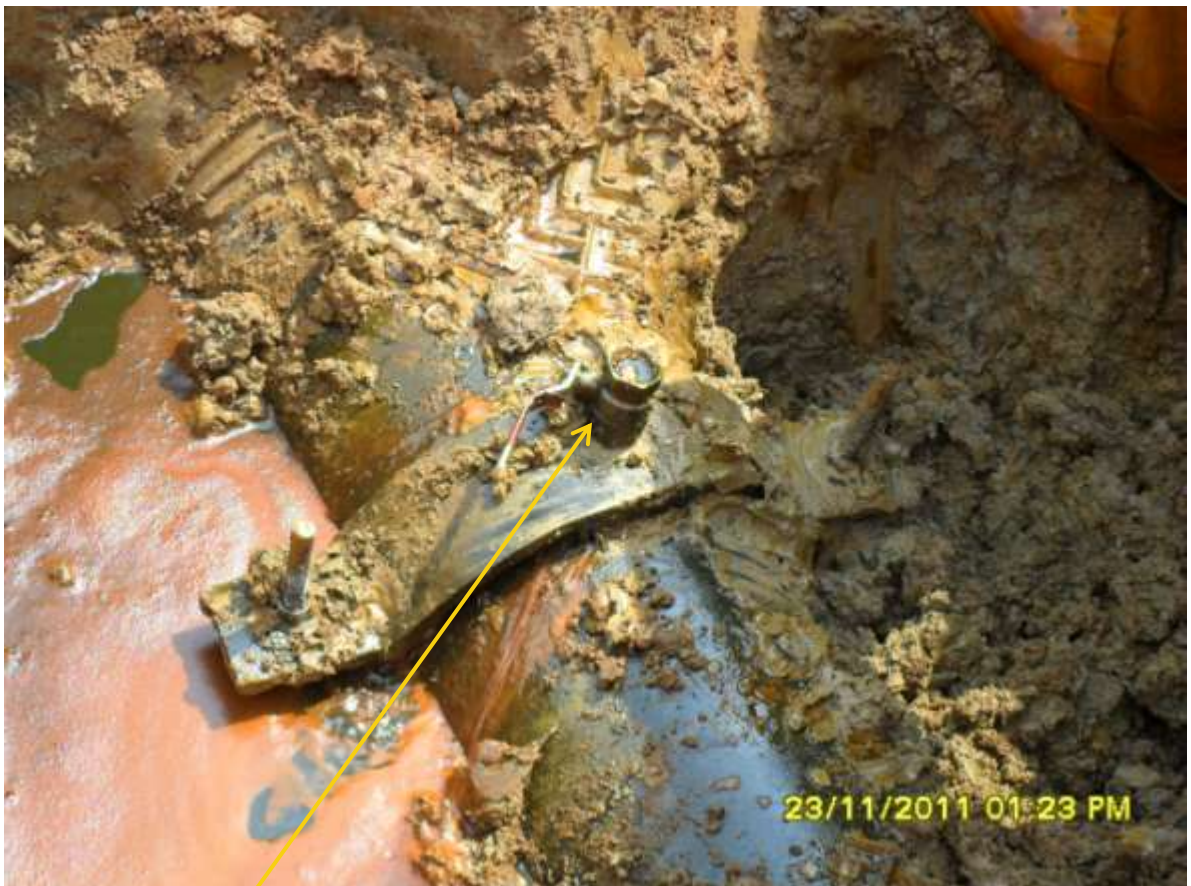
Close-up: Illegal fitting on 12" ImoRiver2-Ebubu pipeline at Odagwa. Picture was taken during Joint Investigation of 23<sup>rd</sup> November, 2011.
