Overview: Part of spill impact on Cawthorne Channel3 Well4LS Flowline Right of Way at Sand Sand. Picture was taken during Joint Investigation of 14th November 2014.

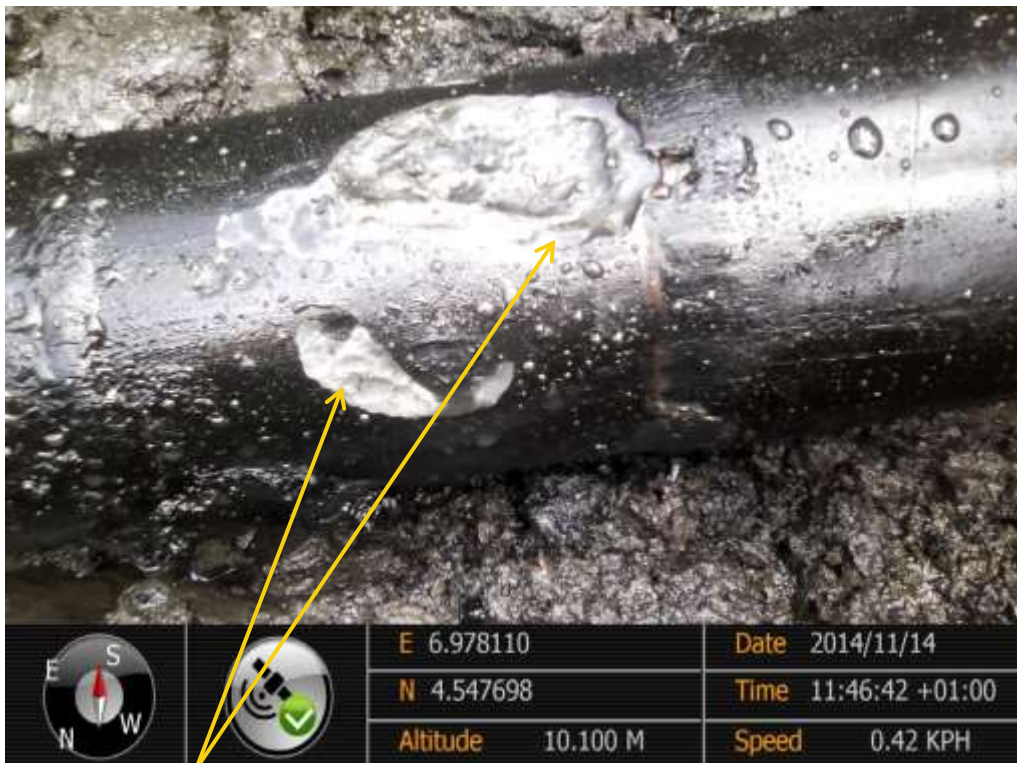
Close-up: Spill due to corrosion on Cawthorne Channel3 Well4LS Flowline at Sand Sand. Picture was taken during Joint Investigation of 14th November 2014.
