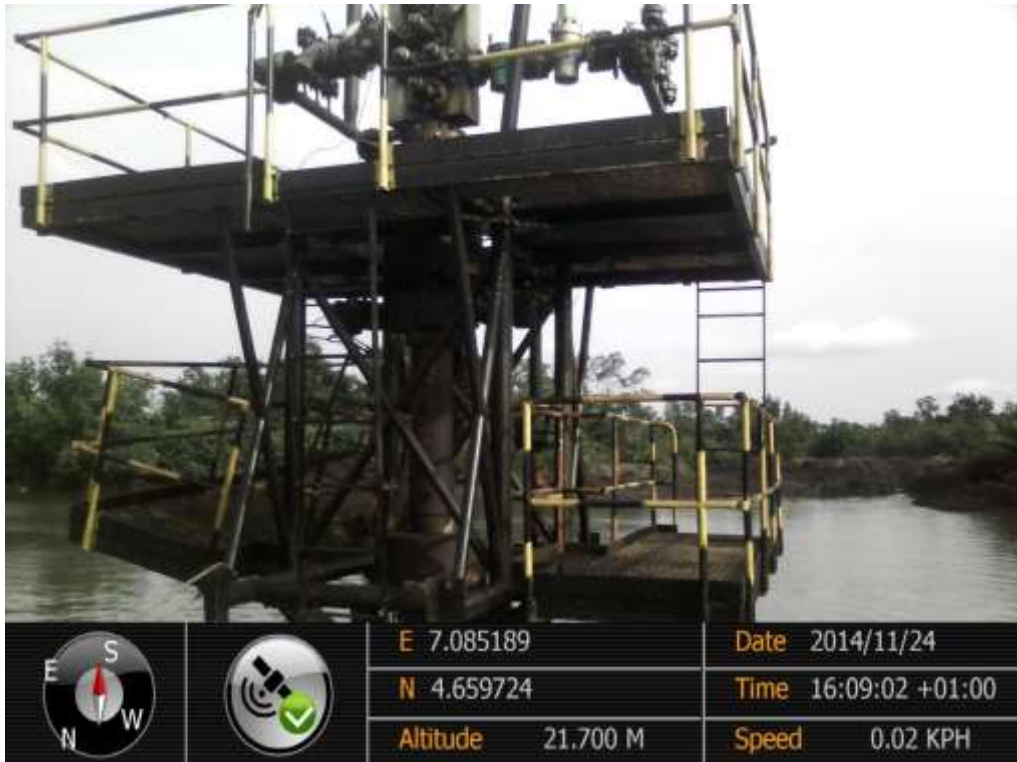
Overview: Spill point on Alakiri Well31L Wellhead at Ofiomina-Ama. Picture was taken during Joint Investigation of 24<sup>th</sup> November 2014.

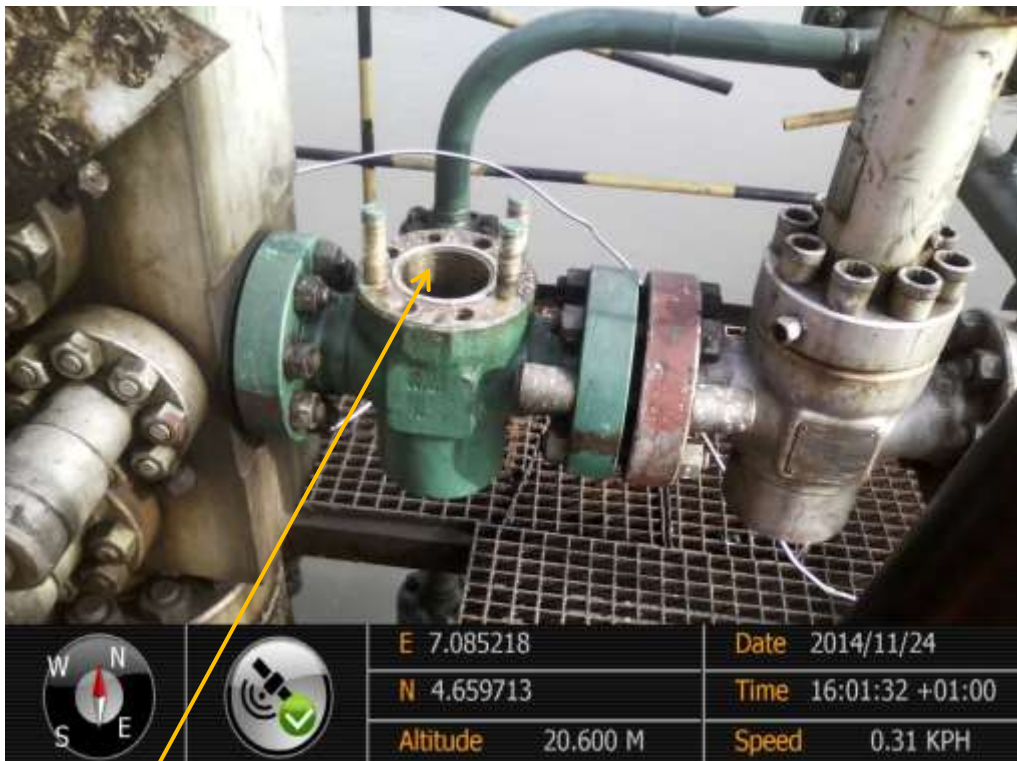
Close-up: Position of missing Surface Safety Valve actuator on Alakiri Well31L Wellhead at Ofiomina-Ama. Picture was taken during Joint Investigation of 24<sup>th</sup> November 2014.

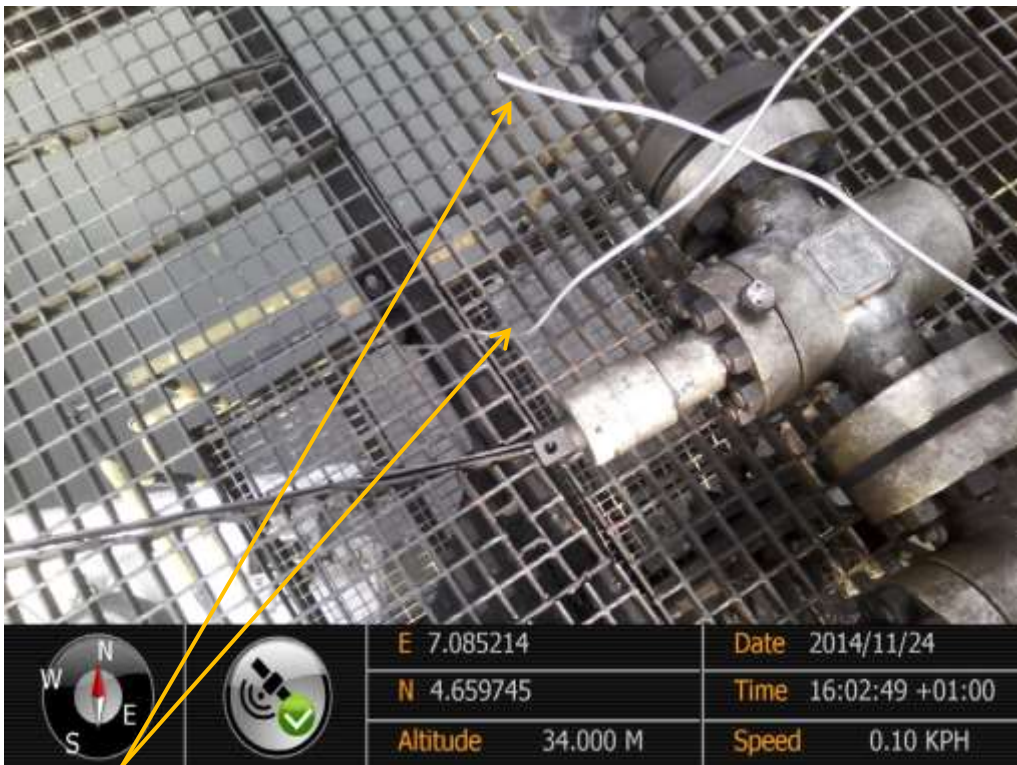
Close-up: Connection points to missing Cameron Control Unit on Alakiri Well31L Wellhead at Ofiomina-Ama. Picture was taken during Joint Investigation of 24<sup>th</sup> November 2014.
