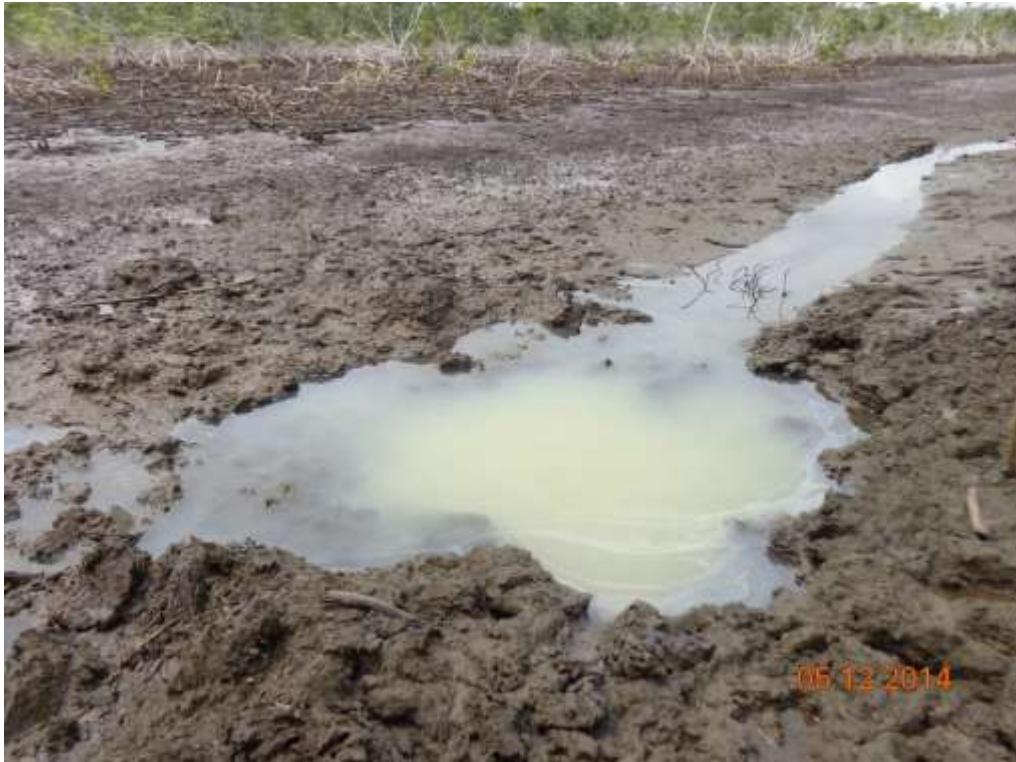
Overview: Spill location on Ekulama 2 Well24T Flowline Right of Way at Freetown. Picture was taken during Joint Investigation of 5<sup>th</sup> December 2014.

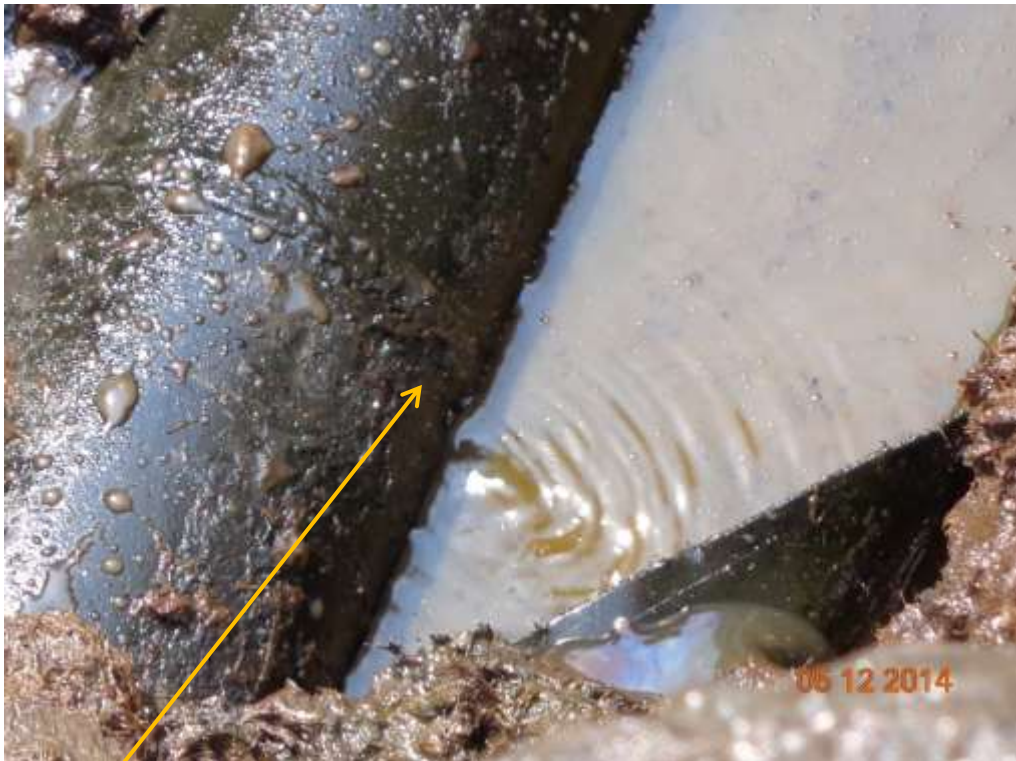
Close-up: Failed weld on Ekulama 2 Well24T Flowline at Freetown. Picture was taken during Joint Investigation of 5<sup>th</sup> December 2014.
