JOINT INVESTIGATION REPORT

INCIDENT NO: 1528955 JIV report S/N: No 0000396

1. Spill incident Number: 1528955 2. Type of incident* OIL SPILL
3. Name of Location BENISEDE WELL-13T WELL HEAD
4. Name of nearest community OJOB0 5. State: BAYELSA LGA EKEREMDR
7. Type of Production facility/Installation WELL HEAD
8. Asset owner/District THE SHELL PETROLEUM DEVELOPMENT COMPANY OF NIGERIA LIMITED / SWAMP WEST

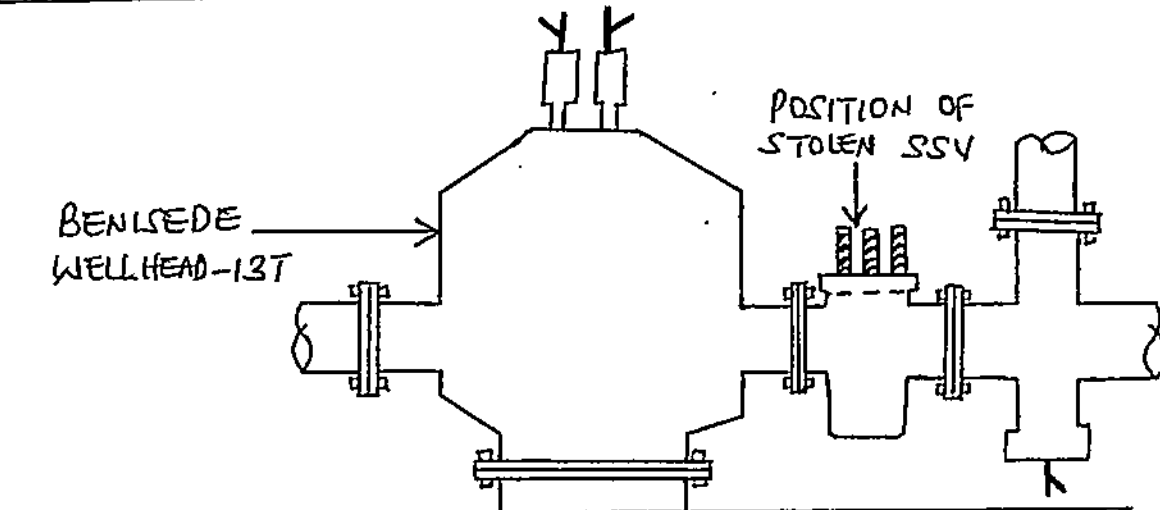
Additional observations around the spill point: ON ARRIVAL AT SITE, THE JOINT INVESTIGATION TEAM OBSERVED THAT THE SURFACE SAFETY VALVE (SSV) ON BENISEDE WELL-13T WELL HEAD HAS BEEN REMOVED BY UNKNOWN PERSONS.

| <input checked="" type="checkbox"/> Others(specify) <u>THEFT OF SURFACE SAFETY VALVE (SSV)</u> | | |

SECTION OF BENISEDE WELL-13T WELLHEAD AT OJOBO AXIS
SHOWING POSITION OF STOLEN SURFACE SAFETY VALVE (SSV)
