JOINT INVESTIGATION REPORT

INCIDENT NO: 2215447 JIV report S/N: 0178

1. Spill incident Number: 2215447 2. Type of incident* OIL SPILL/FIRE
3. Name of Location 24" NKPOKU - BOMU PIPELINE
4. Name of nearest community EGBALOR 5. State: RIVERS 6. LGA ELEME
7. Type of Production facility/Installation OIL PIPELINE
8. Asset owner/District THE SHELL PETROLEUM DEVELOPMENT COMPANY OF NIGERIA
LTD. (S.P.D.C.) / PIPELINE

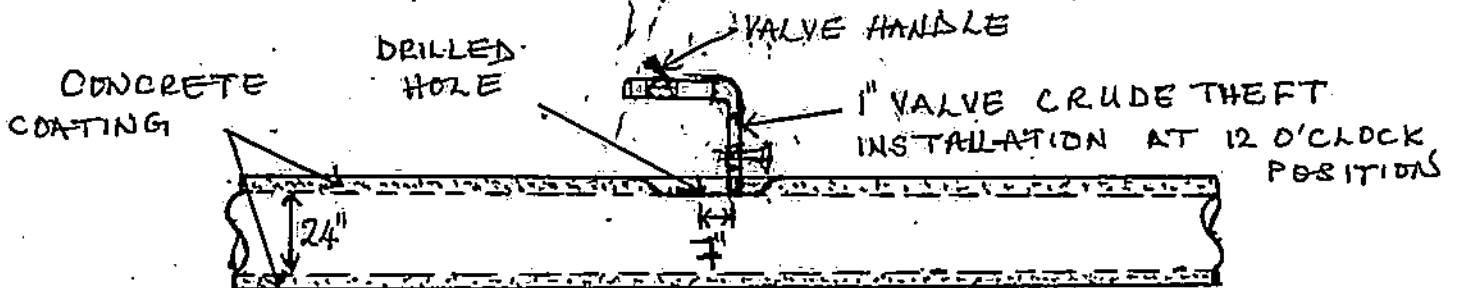
| <input checked="" type="checkbox"/> Crude oil theft (illegal bunkering) point | <input type="checkbox"/> Saver-pit over flow | <input type="checkbox"/> Third party tampering with Clamp |

E. GRAPHIC DESCRIPTION OF LEAK POINT (while detailed report of the leak point should be contained in the leak report, overview sketch of the site should be added as an appendix 1) A SECTION OF 24" NKPOKU - BOMU PIPELINE AT EGBALOR SHOWING 1" VALVE CRUDE THEFT POINT AND A DRILLED HOLE 7" APART AT 12 O'CLOCK POSITIONS BY UNKNOWN PERSONS.
