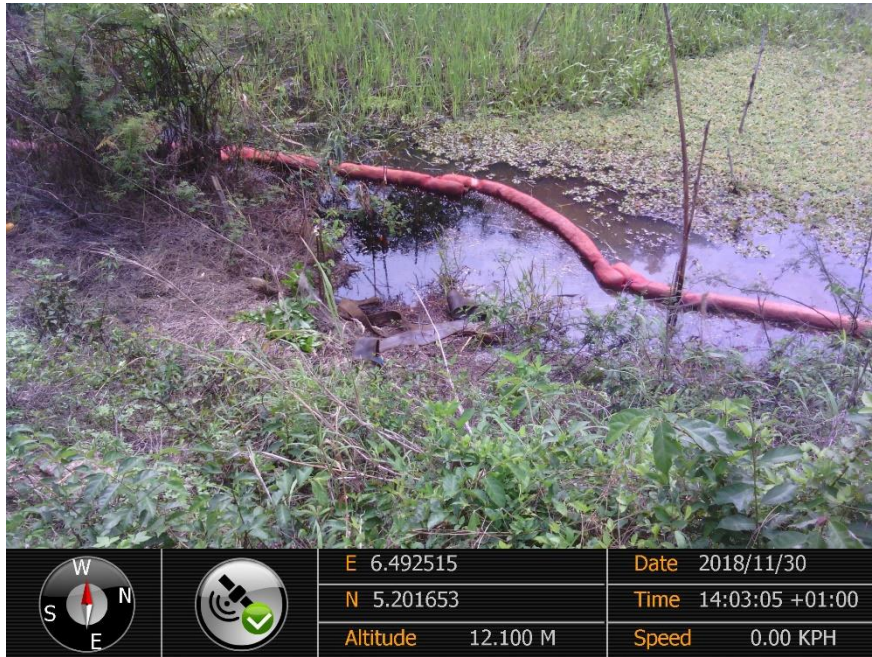
Overview: Part of spill impact on 4" Adibawa Well 12T Flowline at Edagberi. Picture was taken during Joint Investigation of 30<sup>th</sup> November 2018.

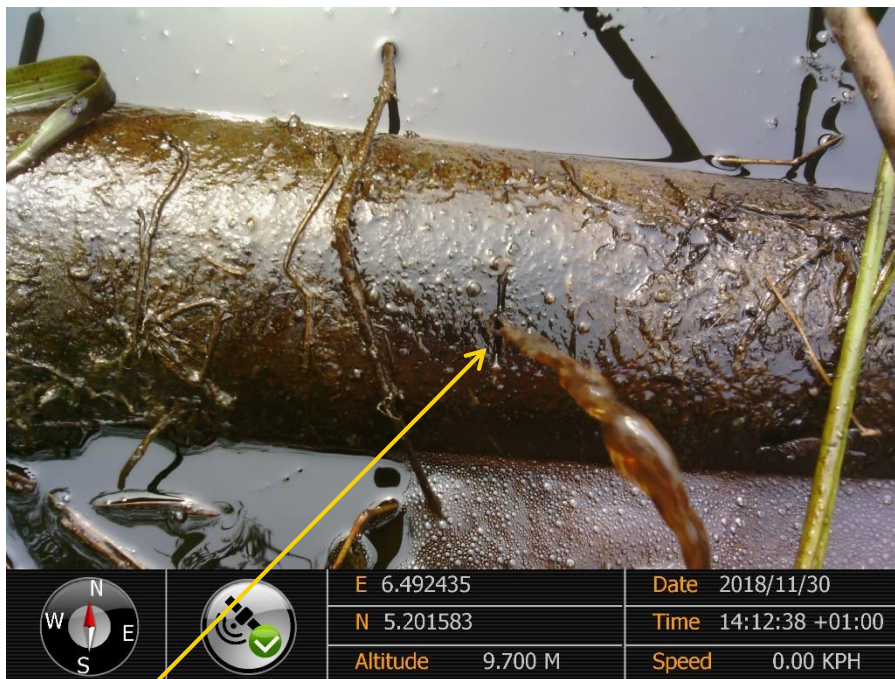
Close-up: Hacksaw Cut on 4" Adibawa Well 12T Flowline at Edagberi. Picture was taken during Joint Investigation of 30<sup>th</sup> November 2018
