# JOINT INVESTIGATION REPORT

INCIDENT NO: 2787185 JIV report S/N:

1. Fountain Incident Number: 2787185 2. Type of incident\* OIL SPILL  
3. Name of Location 24" OGALE - BOMU PIPELINE AT AGBETA  
4. Name of nearest community AGBETA 5. State: RIVERS 6. LGA ELEME  
7. Production Facility/Installation PIPE LINE  
8. Asset Owner/Hub THE SHELL PETROLEUM DEVELOPMENT COMPANY OF NIGERIA LIMITED (SPDC)/PIPE LINE

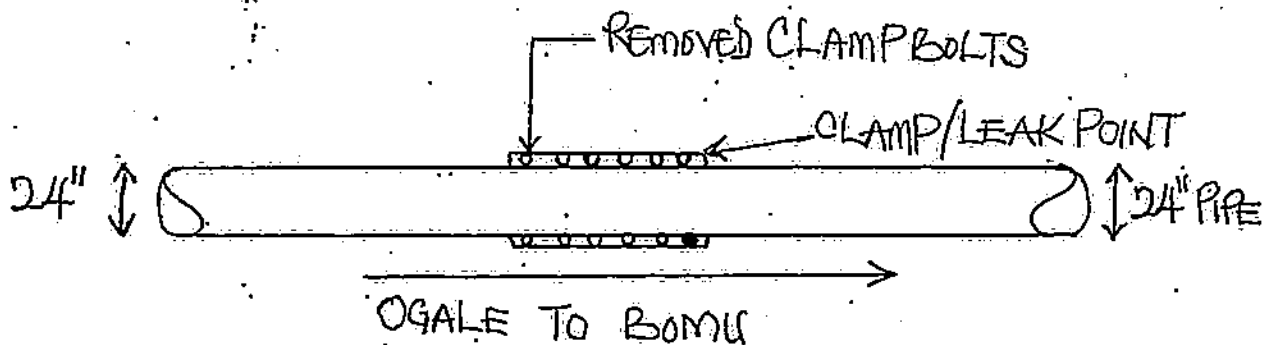
E. GRAPHIC DESCRIPTION OF LEAK POINT (while detailed description of the leak point should be contained in the leak report, overview sketch of the site should be added as appendix 1) A SECTION OF 24"

OGALE - BOMU PIPE LINE AT AGBETA SHOWING VANDALIZED CLAMP BOLTS (11 PIECES OF BOLTS REMOVED) BY UNKNOWN PERSON(S)

CLAMPING ONGOING
