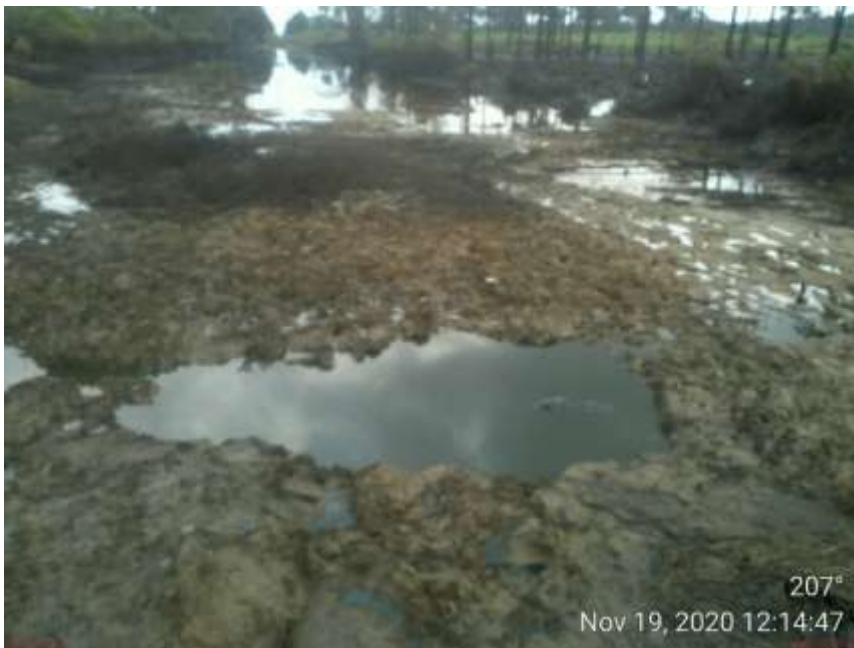
Overview: Part of spill impact on 14inch Okordia Rumuekpe Trunkline at Edeoha. Picture was taken during Joint Investigation on 19th November 2020.

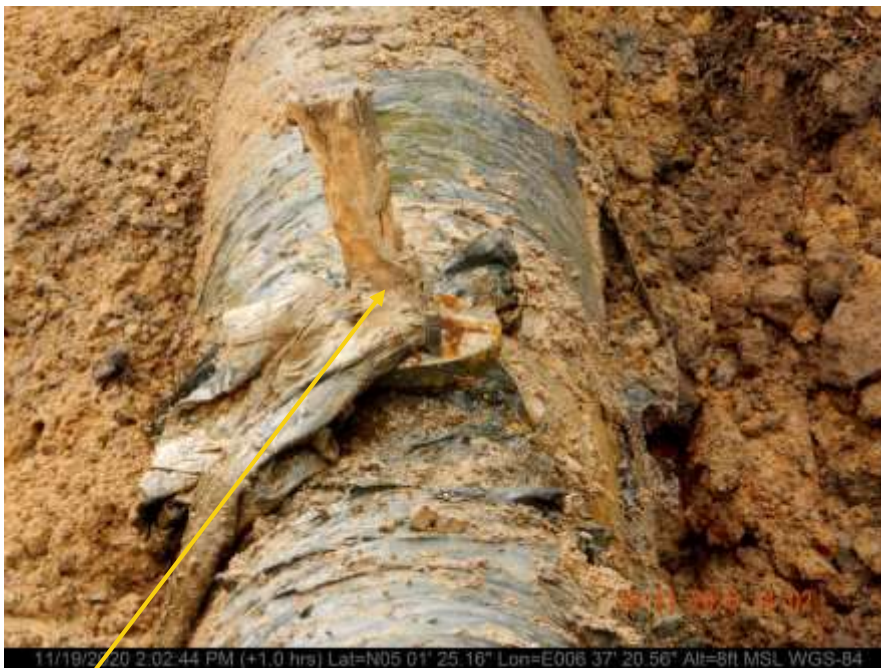
Close-up: Plugged 2inch Ball valve installed at 12 o'clock position on 14inch Okordia Rumuekpe Trunkline at Edeoha. Picture was taken during Joint Investigation on 19th November 2020.
