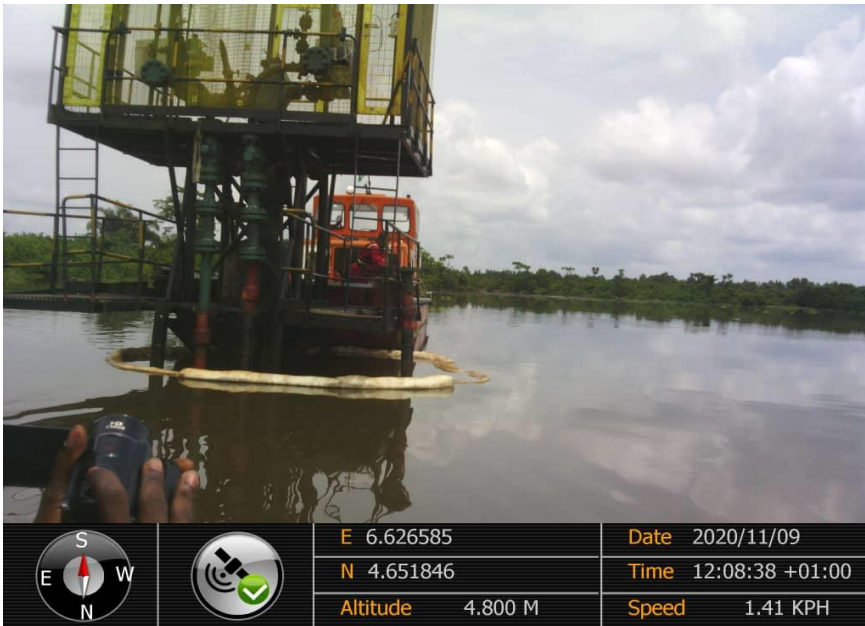
Overview: Part of spill impact on Soku Well 14L at Soku. Picture was taken during Joint Investigation on 9<sup>th</sup> November 2020.

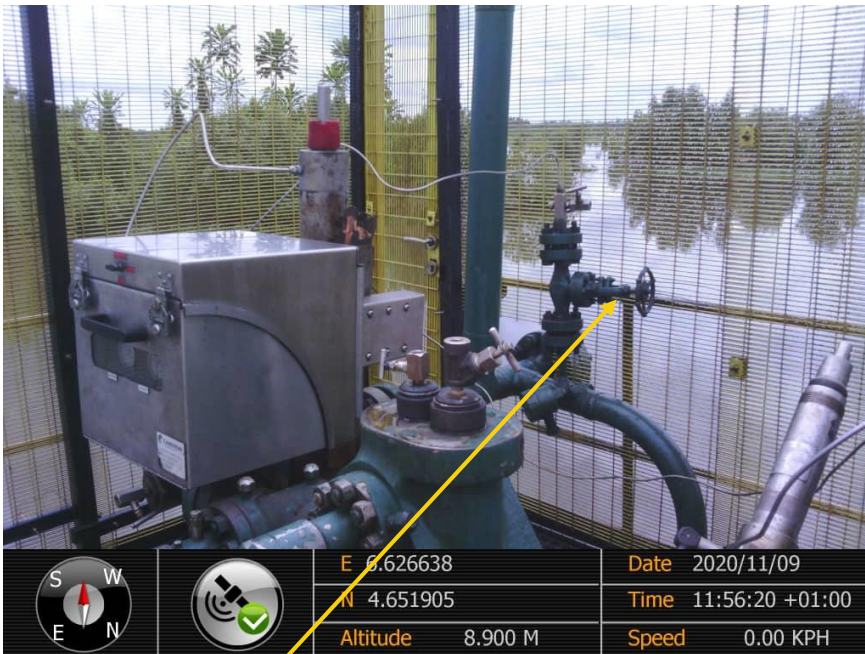
Close-up: Partially closed kerotex valve on Soku Well 14L at Soku. Picture was taken during Joint Investigation on 9<sup>th</sup> November 2020.
