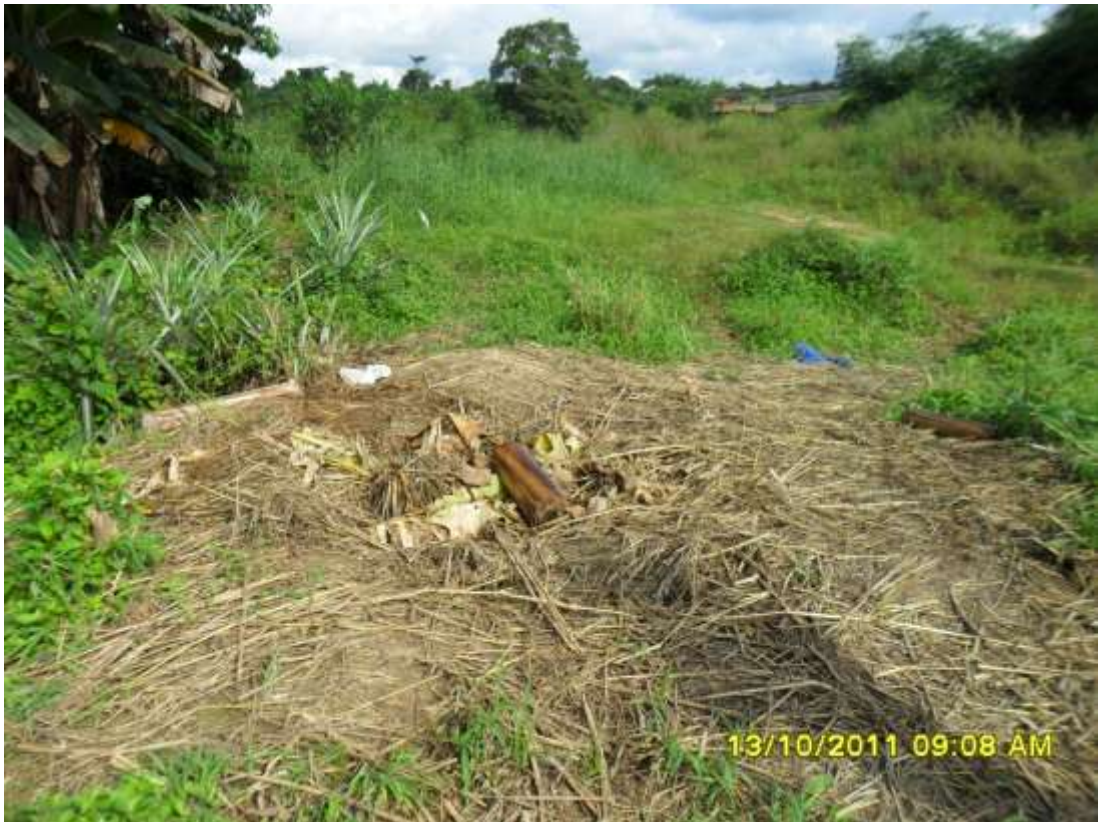
Overview: Location of suspected bunkering point on 12" Egbema-Oguta pipeline right of way at Eziosu. Picture taken during Joint Investigation of 13th October, 2011.

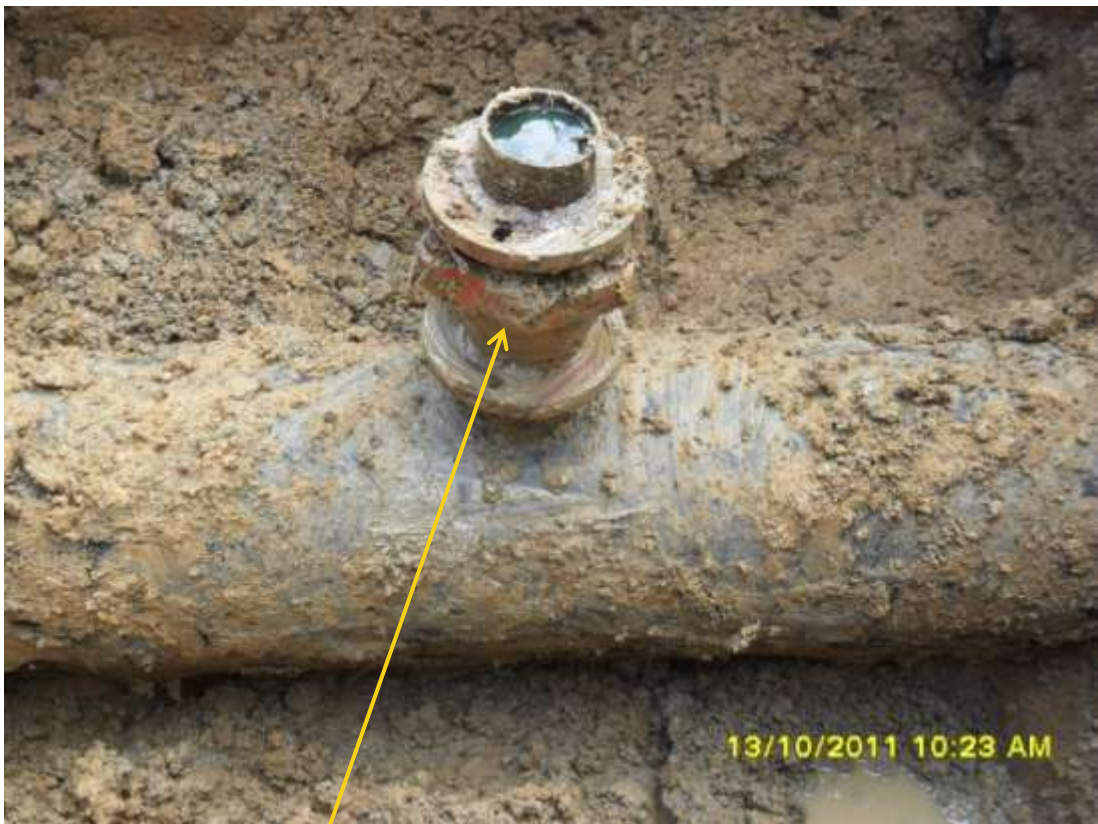
Close-up: Illegal fitting discovered after excavation on 12" Egbema-Oguta pipeline at Eziosu. Picture taken during Joint Investigation of 13th October, 2011.
