JOINT INVESTIGATION REPORT

INCIDENT NO: 1738804 JIV report S/N: Nº 0000376

1. Spill incident Number: 1738804 2. Type of incident* OIL SPILL
3. Name of Location KANBO WELLS - 7L/S AND 9T WELLHEADS CLUSTER
4. Name of nearest community AGBIDIAMA 5. State: BAYELSA 6. LGA EKEREMOR
7. Type of Production facility/Installation WELLHEAD CLUSTER
8. Asset owner/District THE SHELL PETROLEUM DEVELOPMENT COMPANY OF NIGERIA LIMITED/SWAMP WEST

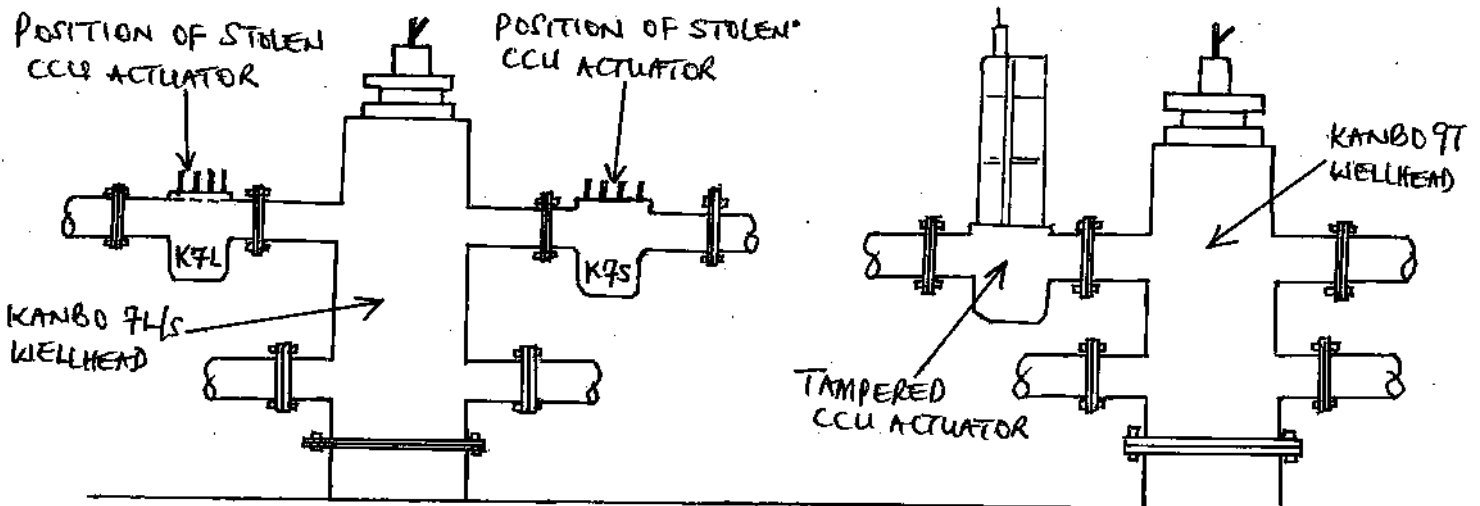
Additional observations around the spill point: ON ASSESSMENT, THE JOINT INVESTIGATION TEAM OBSERVED THAT THE CAMERON CONTROL UNIT (CCU) ACTUATORS ON KANBO WELLS 7L AND 9T WERE REMOVED BY UNKNOWN PERSONS, WHILE THE CCU ACTUATOR ON KANBO WELL - 9T WAS TAMPERED WITH

SECTIONS OF KANBO WELLS - 7L/S AND 9T WELLHEADS CLUSTER AT AEBIDIAMA SHOWING; POSITIONS OF STOLEN CCUs ON KANBO-7L/S AND TAMPERED CCU ON KANBO 9T
