# JOINT INVESTIGATION REPORT

INCIDENT NO: 1737810

No: 0000364

1. Spill incident Number: 1737810 2. Type of incident\* OIL SPILL  
3. Name of Location 6" KANBO WELL - 6T FLOWLINE  
4. Name of nearest community AGBIDIAMA 5. State: BAYELSA 6. LGA EKEREMOR  
7. Type of Production facility/Installation FLOWLINE  
8. Asset owner/District THE SHELL PETROLEUM DEVELOPMENT COMPANY OF

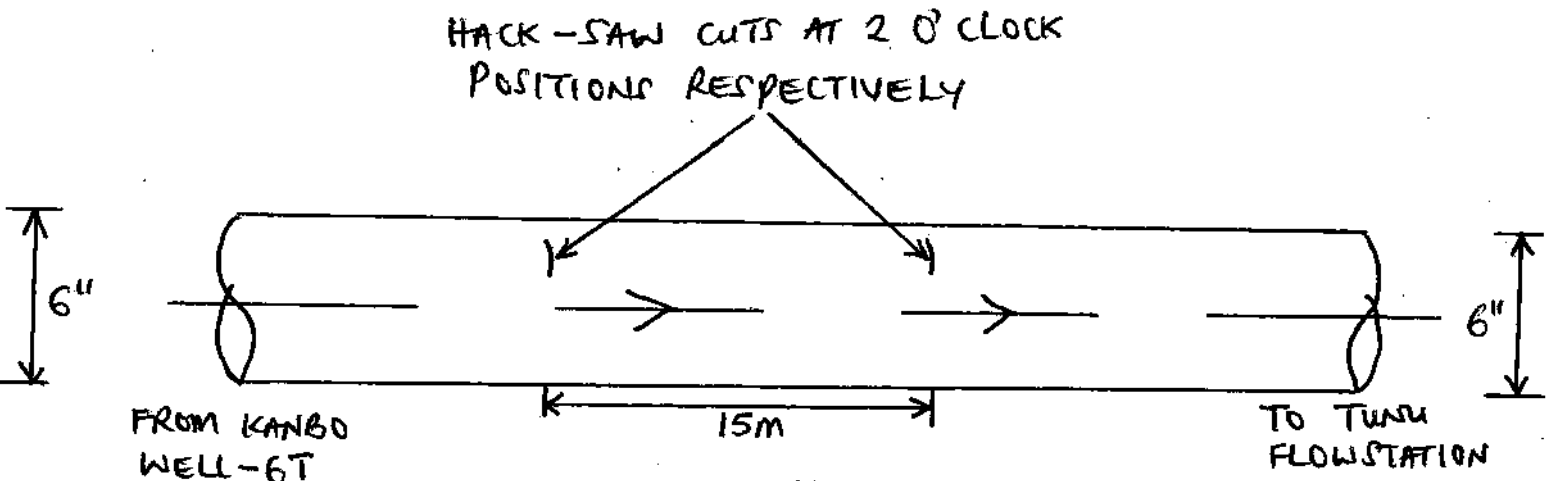
SECTION OF 6" KANBO WELL - 6T FLOWLINE AT AGBIDAMA SHOWING; POSITIONS OF HACK-SAW CUT

Additional observations around the spill point: ON LIFTING THE FLOWLINE, THE JOINT INVESTIGATION TEAM OBSERVED HACK-SAW CUTS AT 2 O' CLOCK POSITIONS RESPECTIVELY, AT A DISTANCE OF ABOUT 15M APART.

| <input type="checkbox"/> Drilled hole | <input checked="" type="checkbox"/> Hack saw cut | <input type="checkbox"/> Tear (_____), |

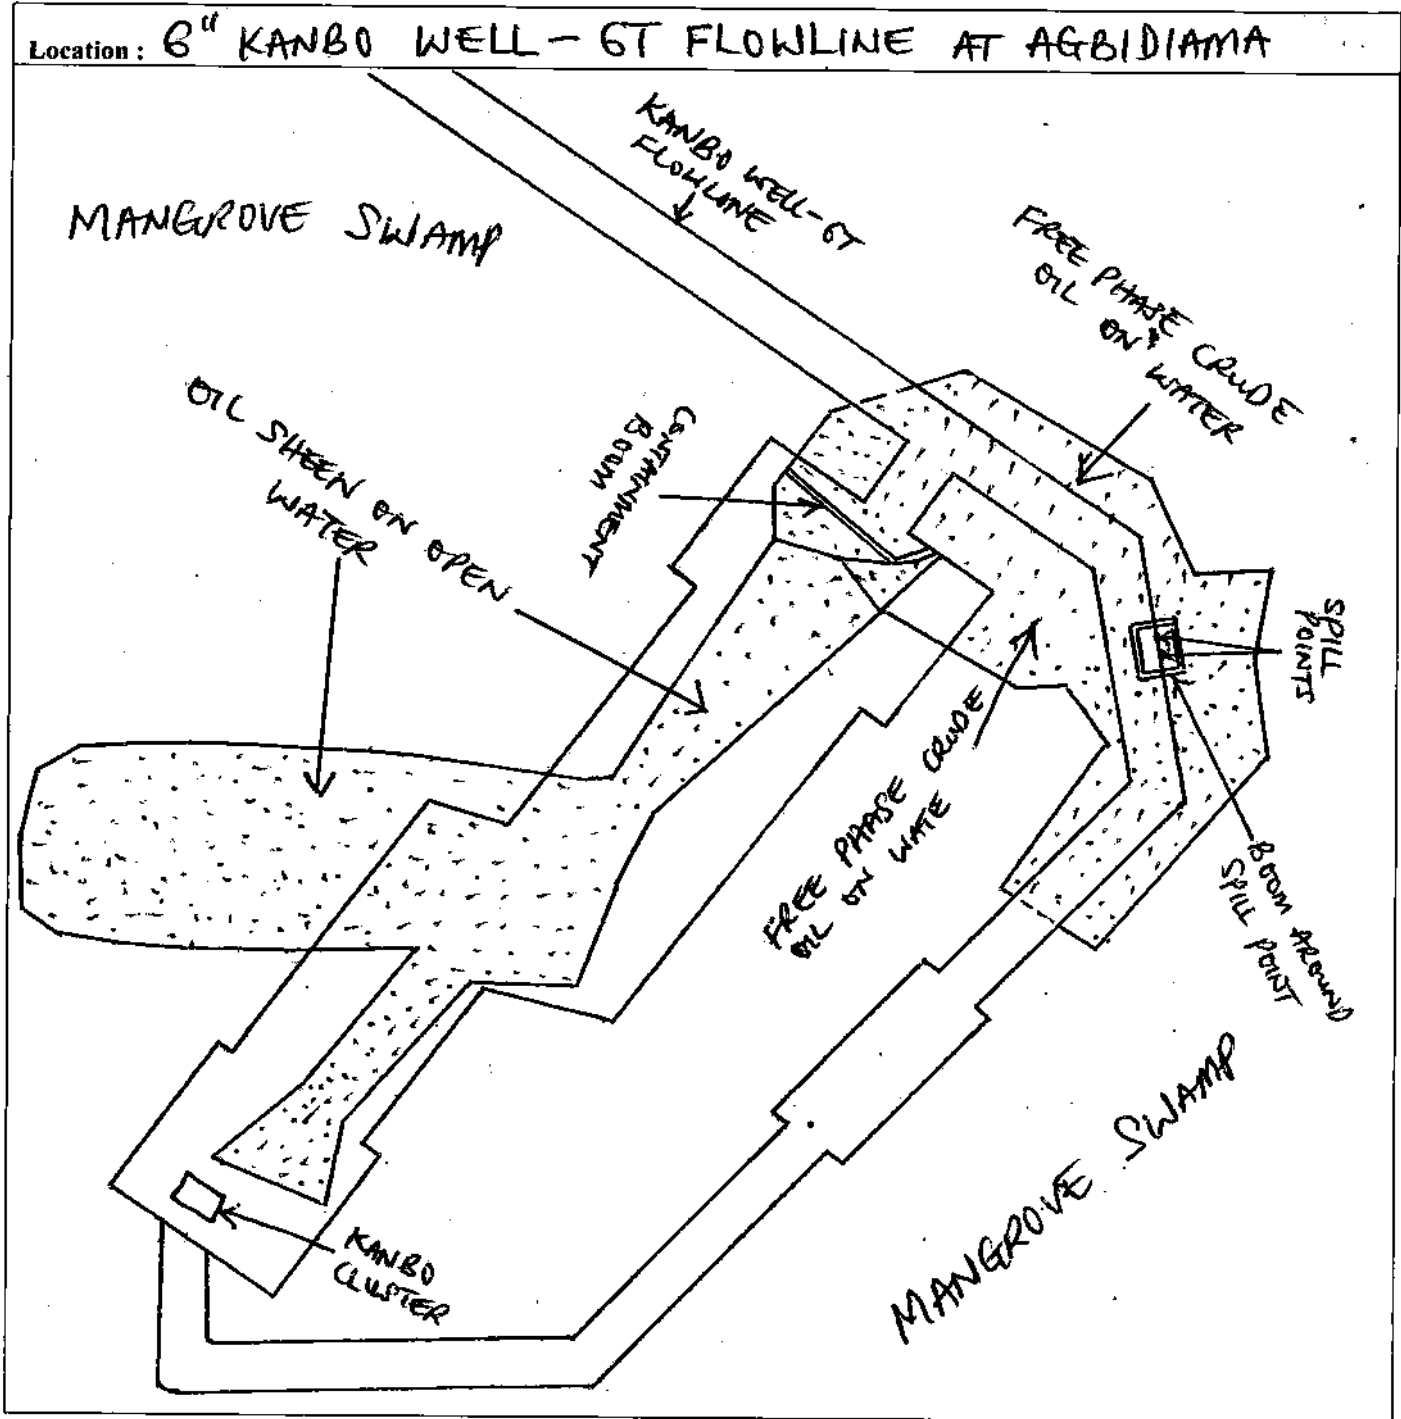
f. Appendix 1: Overview sketch of the site

- Total calculated area of impact OIL ON WATER (FREE PHASE OIL) = 7.69 HA
- Impact within R.O.W OIL STAIN ON WATER (SLOT) = 1.42 HA
- Impact outside R.O.W OIL STAIN ON OPEN RIVER = 20.17 HA
