JOINT INVESTIGATION REPORT

INCIDENT NO: 1730891 JIV report S/N: Nº 0000206

1. Spill incident Number: 1730891 2. Type of incident* OIL SPILL
3. Name of Location 28" BOMU - BONNY PIPELINE
4. Name of nearest community OKOLO LAUNCH 5. State: RIVERS 6. LGA ANDONI
7. Type of Production facility/Installation OIL PIPELINE
8. Asset owner/District THE SHELL PETROLEUM DEVELOPMENT COMPANY OF NIGERIA LIMITED/PIPELINE

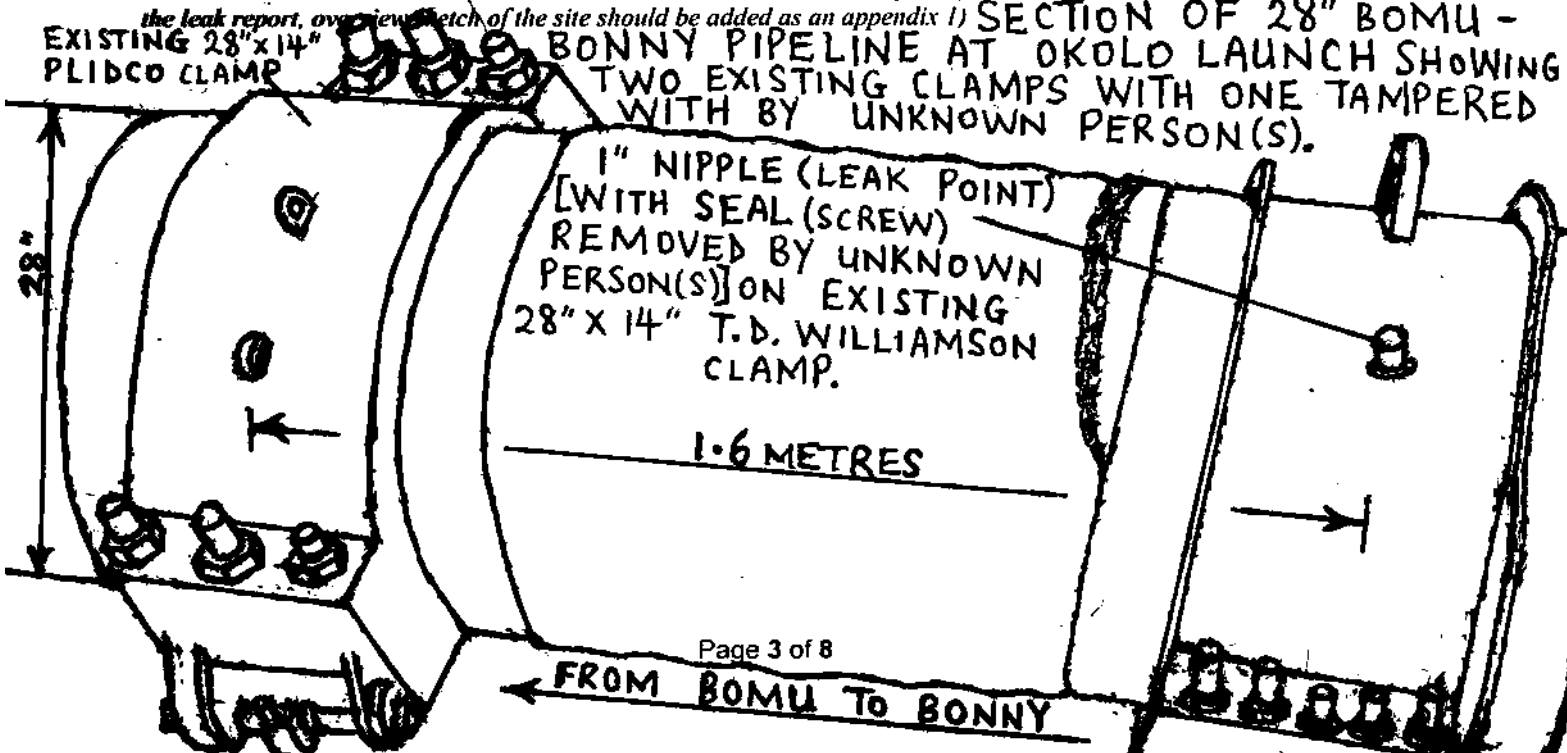
Additional observations around the spill point: PREPARATORY TO THE SECOND DAY OF JOINT INVESTIGATION VISIT (J.I.V.), A COFFERDAM WAS CONSTRUCTED AROUND THE SPILL POINT BY THE SPDC ASSET OWNER. ON EXPOSURE, TWO EXISTING CLAMPS WERE NOTICED WITH LEAK CONFIRMED FROM ONE DUE TO TAMPERING WITH BY UNKNOWN PERSON(S).

| <input type="checkbox"/> Crude oil theft (illegal bunkering) point, | <input type="checkbox"/> Saver-pit over flow | <input checked="" type="checkbox"/> Third party tampering with Clamp |

the leak report, over view sketch of the site should be added as an appendix 1) SECTION OF 28" BOMU - BONNY PIPELINE AT OKOLO LAUNCH SHOWING TWO EXISTING CLAMPS WITH ONE TAMPERED WITH BY UNKNOWN PERSON(S).

REPAIR WAS BEING PLANNED BY CLAMPING.
