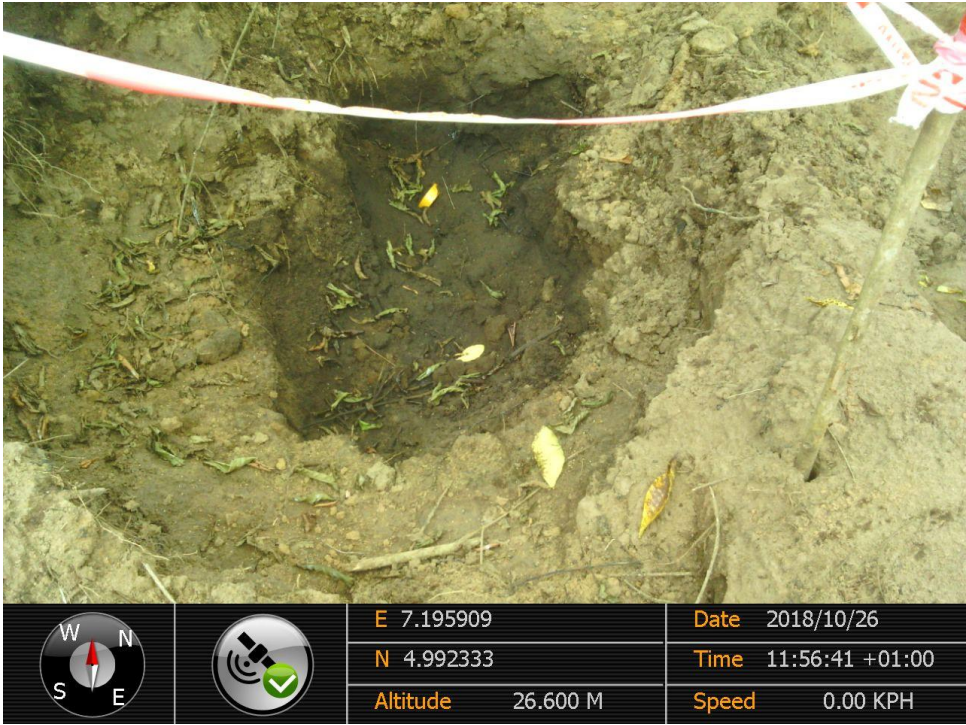
**Overview:** Part of spill impact on Imo River1–Well 37 Flowline at Igiriukwu-Owaza. Picture was taken during Joint Investigation of 26<sup>th</sup> October 2018.

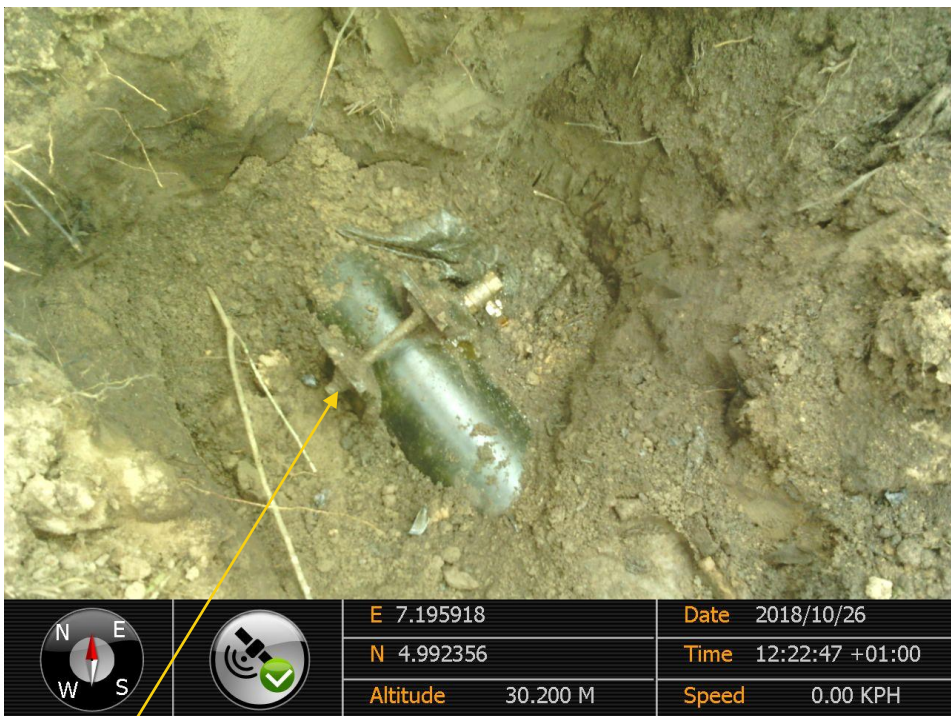
**Close up:** Illegal fitting on Imo River1–Well 37 Flowline at Igiriukwu-Owaza. Picture was taken during Joint Investigation of 26<sup>th</sup> October 2018.
