# JOINT INVESTIGATION REPORT

INCIDENT NO: 2185038 JIV report S/N: 0165

1. Spill incident Number: 2185038 2. Type of incident\*: OIL SPILL  
3. Name of Location: 20" K. OLODCREEK - RUMUEKPE PIPELINE  
IMDQU -  
4. Name of nearest community: RUMUEKPE 5. State: RIVERS 6. LGA: EMOHUA  
7. Type of Production facility/Installation: OIL PIPELINE  
8. Asset owner/District: THE SHELL PETROLEUM DEVELOPMENT COMPANY OF NIGERIA LTD  
(SPDC) / PIPELINE

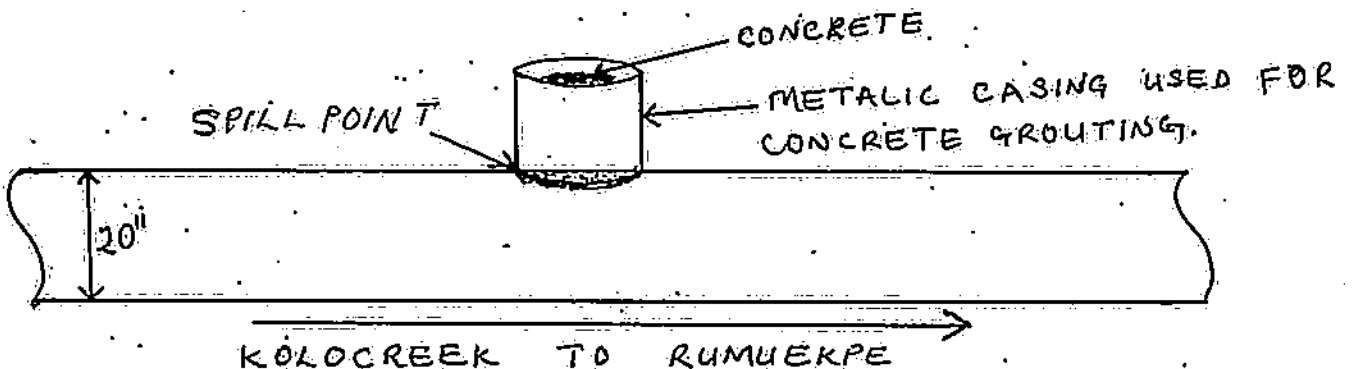
Additional observations around the spill point: THE JOINT INVESTIGATION TEAM OBSERVED LEAK FROM THE CRUDE THEFT VALVE.

| <input checked="" type="checkbox"/> Crude oil theft (illegal bunkering) point | <input type="checkbox"/> Saver-pit over flow | <input type="checkbox"/> Third party tampering with Clamp |

**E. GRAPHIC DESCRIPTION OF LEAK POINT** (while detailed report of the leak point should be contained in the leak report, overview sketch of the site should be added as an appendix 1) A SECTION OF 20" KOLOCREEK-RUMUEKPE PIPELINE AT IMOGLU-RUMUEKPE SHOWING CONCRETE GROUTING ON AN ILLEGAL CONNECTION AT 12 O'CLOCK POSITION DONE BY SPDC TO PREVENT CONTINUED CRUDE THEFT, FROM PREVIOUSLY REPORTED CRUDE THEFT POINT.

REPAIR BY CLAMPING
