JOINT INVESTIGATION REPORT

INCIDENT NO: 2193585 JIV report S/N:0052

1. Spill incident Number: 2193585 2. Type of incident* OIL SPILL
3. Name of Location 4" BONNY WELL-18S FLOWLINE RISER
4. Name of nearest community OLOMA 5. State: RIVERS 6. LGA BONNY
7. Type of Production facility/Installation FLOWLINE/WELLHEAD
8. Asset owner/District THE SHELL PETROLEUM DEVELOPMENT COMPANY OF NIGERIA LIMITED/CENTRAL EAST

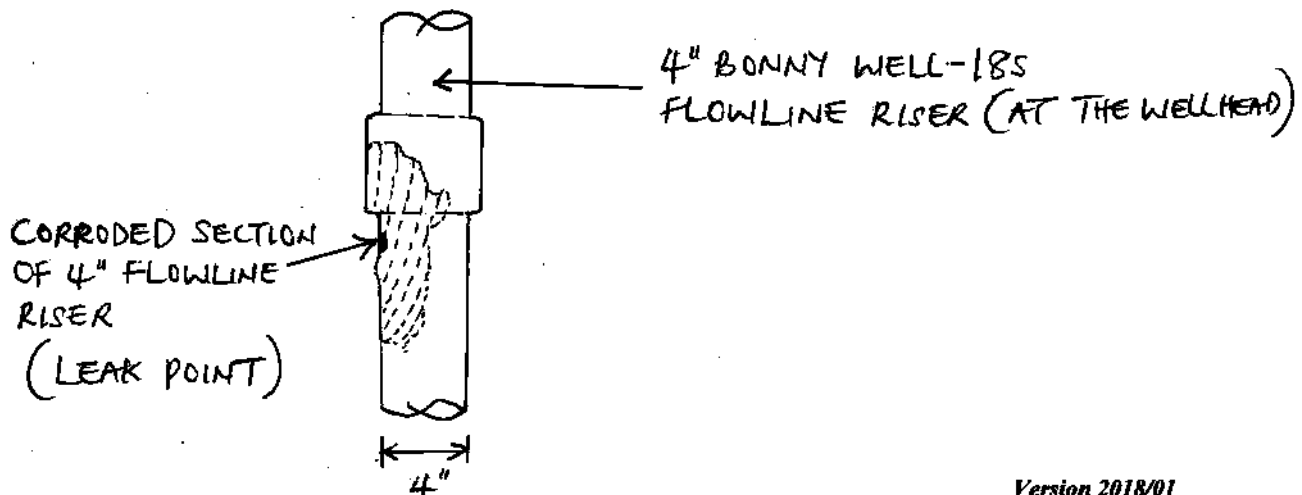
Additional observations around the spill point: CAUSE OF LEAK WAS CONFIRMED TO BE OPERATIONAL, ESTABLISHED DURING ASSESSMENT OF THE CORRODED SECTION OF 4" BONNY WELL-18S FLOWLINE RISER (AT THE WELLHEAD).

SECTION OF 4" BONNY WELL-18S FLOWLINE RISER (AT THE WELLHEAD)
IN OLOMA, SHOWING CORRODED LEAK POINT
