JOINT INVESTIGATION REPORT

INCIDENT NO: 2186978 JIV report S/N: 0159

1. Spill incident Number: 2186978 2. Type of incident*: OIL SPILL
3. Name of Location: 20" KOLA CREEK - RUMUEKPE PIPELINE
4. Name of nearest community OKPOROWO 5. State: RIVERS 6. LGA AYOADA-EAST
7. Type of Production facility/Installation: OIL PIPELINE
8. Asset owner/District: THE SHELL PETROLEUM DEVELOPMENT COMPANY OF NIGERIA LIMITED PIPELINE.

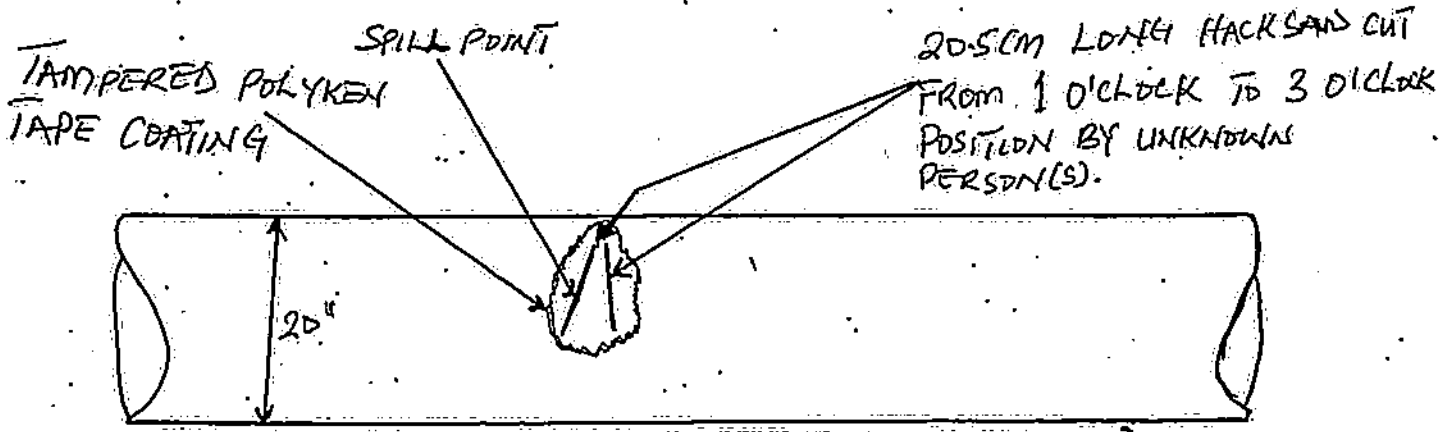
Additional observations around the spill point: THE JOINT INVESTIGATION TEAM OBSERVED THE POLYKEN TAPE COATING AT THE SPILL POINT WAS TAMPERED WITH BY UNKNOWN PERSON(S).

| <input type="checkbox"/> Drilled hole | <input checked="" type="checkbox"/> Hack saw cut | <input type="checkbox"/> Tear (_____) |

E. GRAPHIC DESCRIPTION OF LEAK POINT (while detailed report of the leak point should be contained in the leak report, overview sketch of the site should be added as an appendix 1) SECTIONAL VIEW OF 20" KOLBO CREEK - RUMUEKPE PIPELINE AT ORPORDINBO SADDLING
2 NOS. HACKSAW CUTS BY UNKNOWN PERSON(S).

REPAIR BY CLAMPING ON GDSNG.
