JOINT INVESTIGATION REPORT

INCIDENT NO: 2190987 JIV report S/N: 0231

1. Spill incident Number: 2190987 2. Type of incident* OIL SPILL
3. Name of Location 18" SOKU - BUQUA PIPELINE
4. Name of nearest community SOKU 5. State: RIVERS 6. LGA AKUKU/TORU
7. Type of Production facility/Installation OIL PIPELINE
8. Asset owner/District THE SHELL PETROLEUM DEVELOPMENT COMPANY OF NIGERIA LTD
(SPDC)/PIPELINE

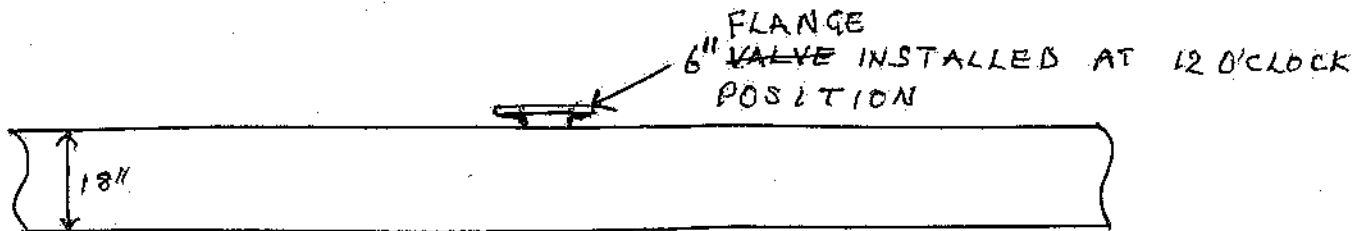
E. GRAPHIC DESCRIPTION OF LEAK POINT (while detailed report of the leak point should be contained in the leak report, overview sketch of the site should be added as an appendix 1) A SECTION OF 18" SOKU - BUGUMA PIPELINE AT SOKU SHOWING 6" FLANGE INSTALLED AT 12 O'CLOCK POSITION BY UNKNOWN PERSONS.

REPAIR BY CLAMPING
