JOINT INVESTIGATION REPORT

INCIDENT NO: 2471501 JIV report S/N: 1030147

1. Fountain Incident Number: 2471501 2. Type of incident* OIL SPILL
3. Name of Location 14" OKORDIA = RUMUEKPE PIPELINE
4. Name of nearest community IKATA 5. State: RIVERS 6. LGA ALHOANA EAST
7. Type of Production facility/Installation OIL PIPELINE
8. Asset owner/District THE SHELL PETROLEUM DEVELOPMENT COMPANY OF NIGERIA LIMITED (SPDC)/PIPELINE

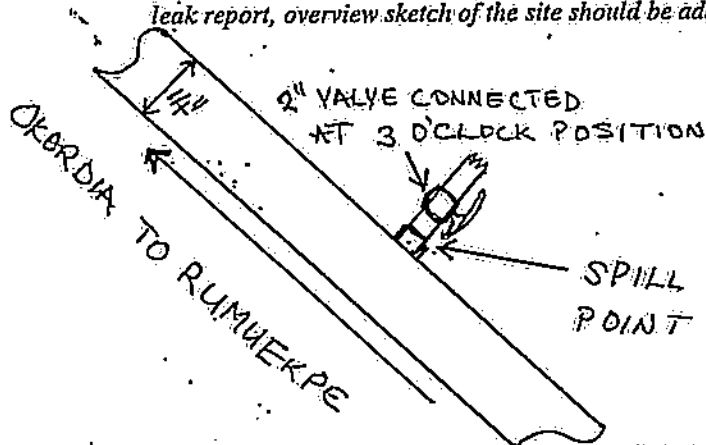
| <input checked="" type="checkbox"/> Failed Weld-on illegal hot tap valve | <input type="checkbox"/> Failed Clamp, | <input type="checkbox"/> Missing Pipeline/Flowline |
| <input checked="" type="checkbox"/> Crude oil theft (illegal bunkering) point, | <input type="checkbox"/> Saver-pit over flow | <input type="checkbox"/> Third party tampering with Clamp |

— RUMUEKPE PIPELINE AT IKATA SHOWING 2" VALVE CRUDE OIL THEFT POINT INSTALLED AT 3 O'CLOCK POSITION BY UNKNOWN PERSON(S)

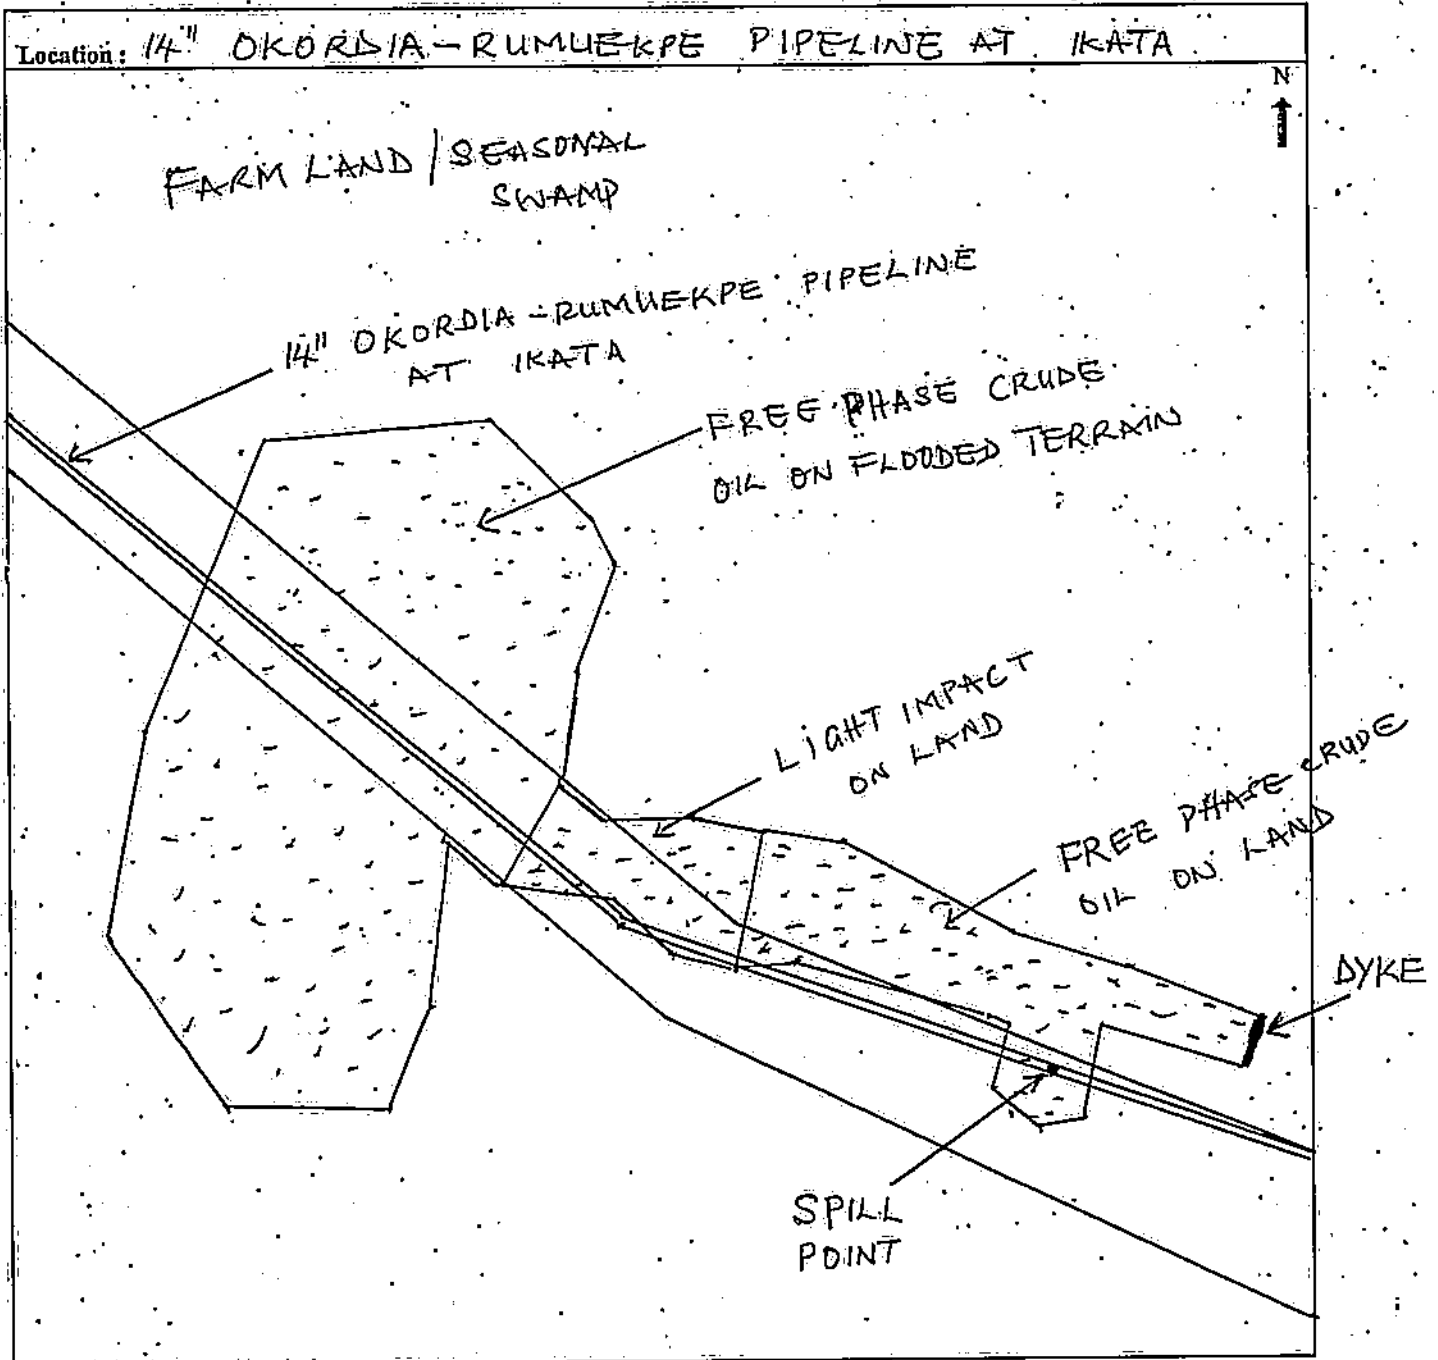
f. Appendix 1: Overview sketch of the site

- Total calculated area of impact 0.60 ha
- Impact within SPDC R.O.W. YES
- Impact outside SPDC R.O.W. YES
