# JOINT INVESTIGATION REPORT

INCIDENT NO: 2478124 JIV report S/N: 1030149

1. Fountain Incident Number: 2478124 2. Type of incident\* OIL SPILL  
3. Name of Location 24" NKPOKU - BOMU PIPELINE  
4. Name of nearest community EGBALOR 5. State: RIVERS 6. LGA ELEME  
7. Type of Production facility/Installation OIL PIPELINE  
8. Asset owner/District THE SHELL PETROLEUM DEVELOPMENT COMPANY OF NIGERIA LTD (SPDC) / PIPELINE

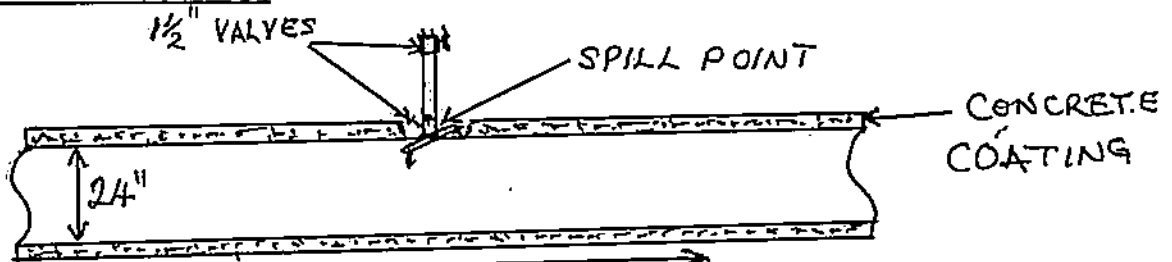
| <input checked="" type="checkbox"/> Crude oil theft (illegal bunkering) point, | <input type="checkbox"/> Saver-pit over flow | <input type="checkbox"/> Third party tampering with Clamp |

- Third party interference (Sabotage ; crude theft ; Line theft ; Accidental 3<sup>rd</sup> party damage   
 Operational  Others (including Mystery spills) \_\_\_\_\_

**E. GRAPHIC DESCRIPTION OF LEAK POINT** (while detail report of the leak point should be contained in the leak report, overview sketch of the site should be added as an appendix 1) A SECTION OF 24" NKPOKU - BOMU PIPELINE AT EGBALORO SHOWING 1/2" VALVE CRUDE THEFT POINT INSTALLED AT 12 O'CLOCK POSITION BY UNKNOWN PERSONS

REPAIR BY CLAMPING

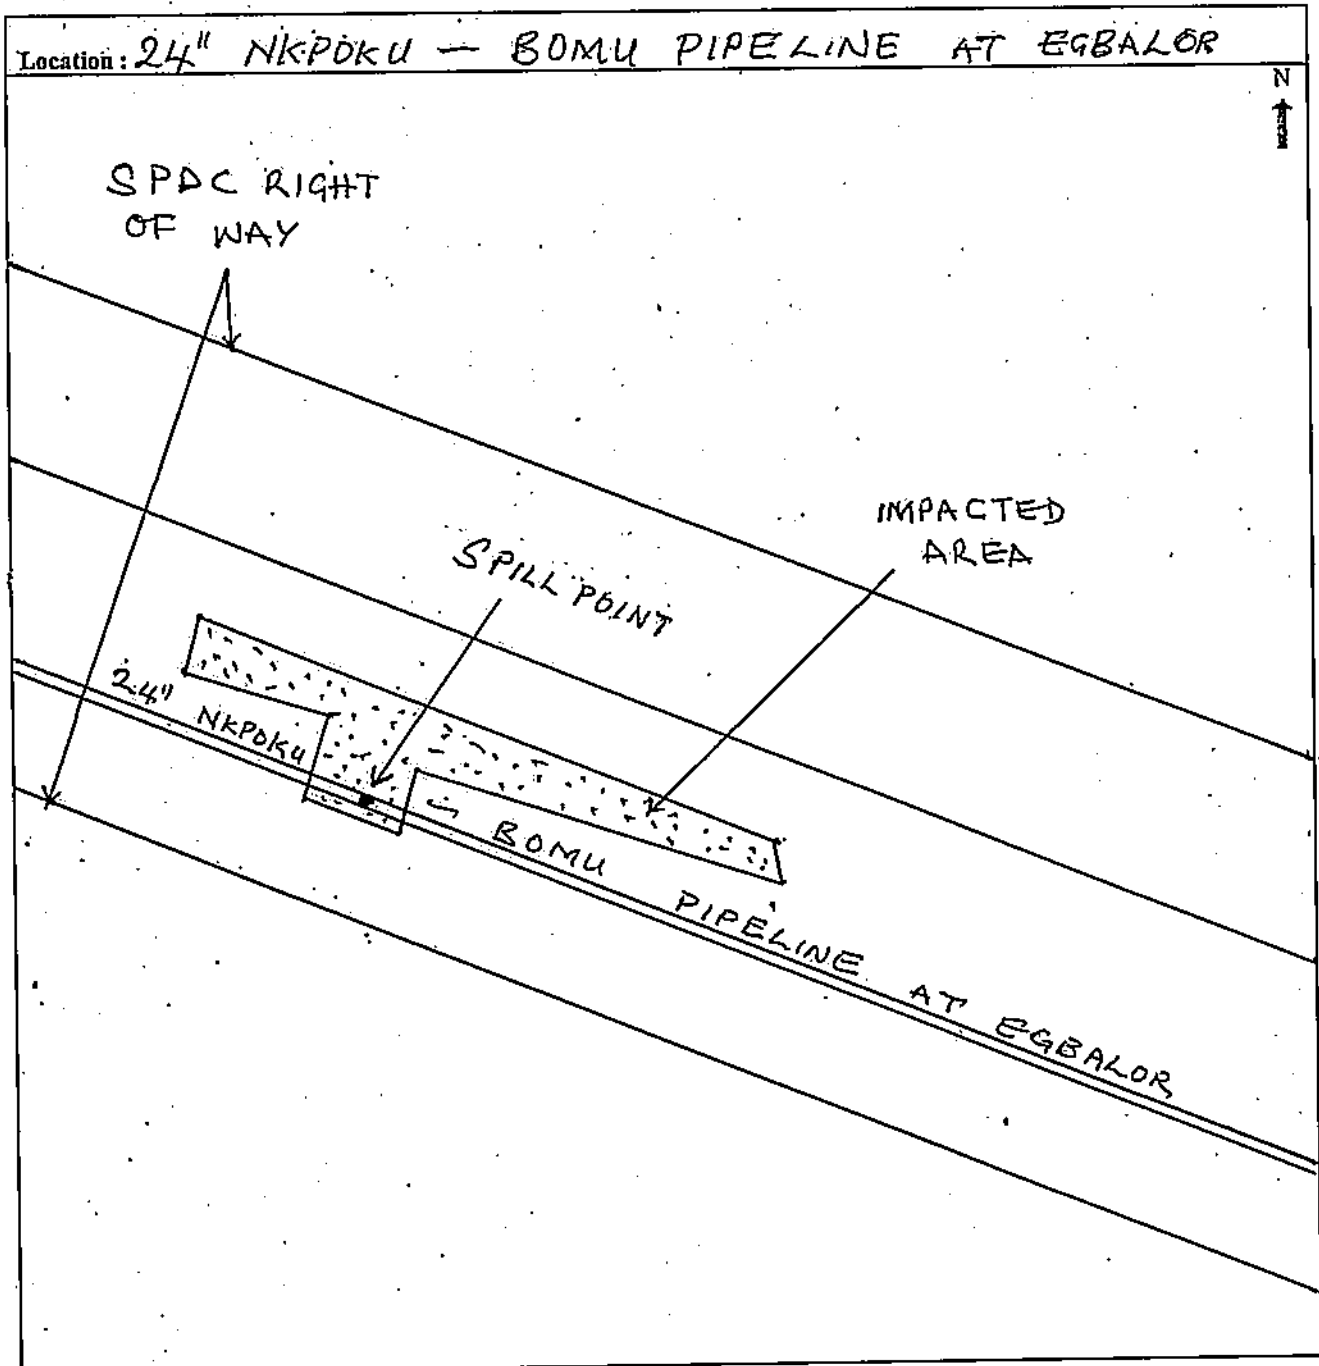
f. Appendix 1: Overview sketch of the site

- Total calculated area of impact 0.018768 HA
- Impact within SPDC R.O.W. YES
- Impact outside SPDC R.O.W. NO
