JOINT INVESTIGATION REPORT

INCIDENT NO: 2475895 JIV report S/N: 1030151

1. Fountain Incident Number: 2475895 2. Type of incident* OIL SPILL
3. Name of Location 14" OKORDIA-RUMUEKPE PIPELINE
4. Name of nearest community IKARAMA 5. State: BATELSA 6. LGA YENEGODA
7. Type of Production facility/Installation OIL PIPELINE
8. Asset owner/District THE SHELL PETROLEUM DEVELOPMENT COMPANY OF NIGERIA LIMITED (SPDC) PIPELINE

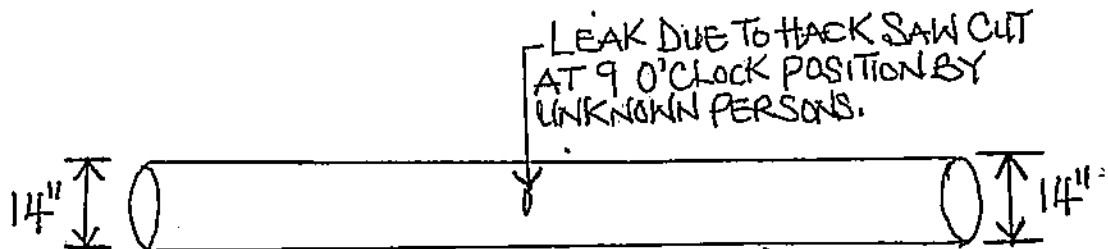
E. GRAPHIC DESCRIPTION OF LEAK POINT (while detail report of the leak point should be contained in the leak report, overview sketch of the site should be added as an appendix 1) A SECTION OF 14" OKORDIA - RUMUKPE AT IKARAMA SHOWING HACK SAW CUT AT 9 O'CLOCK POSITION BY UNKNOWN PERSONS.

FROM OKORDIA - RUMUKPE PIPELINE Version 2019/01

REPAIR ACTIVITY ONGOING

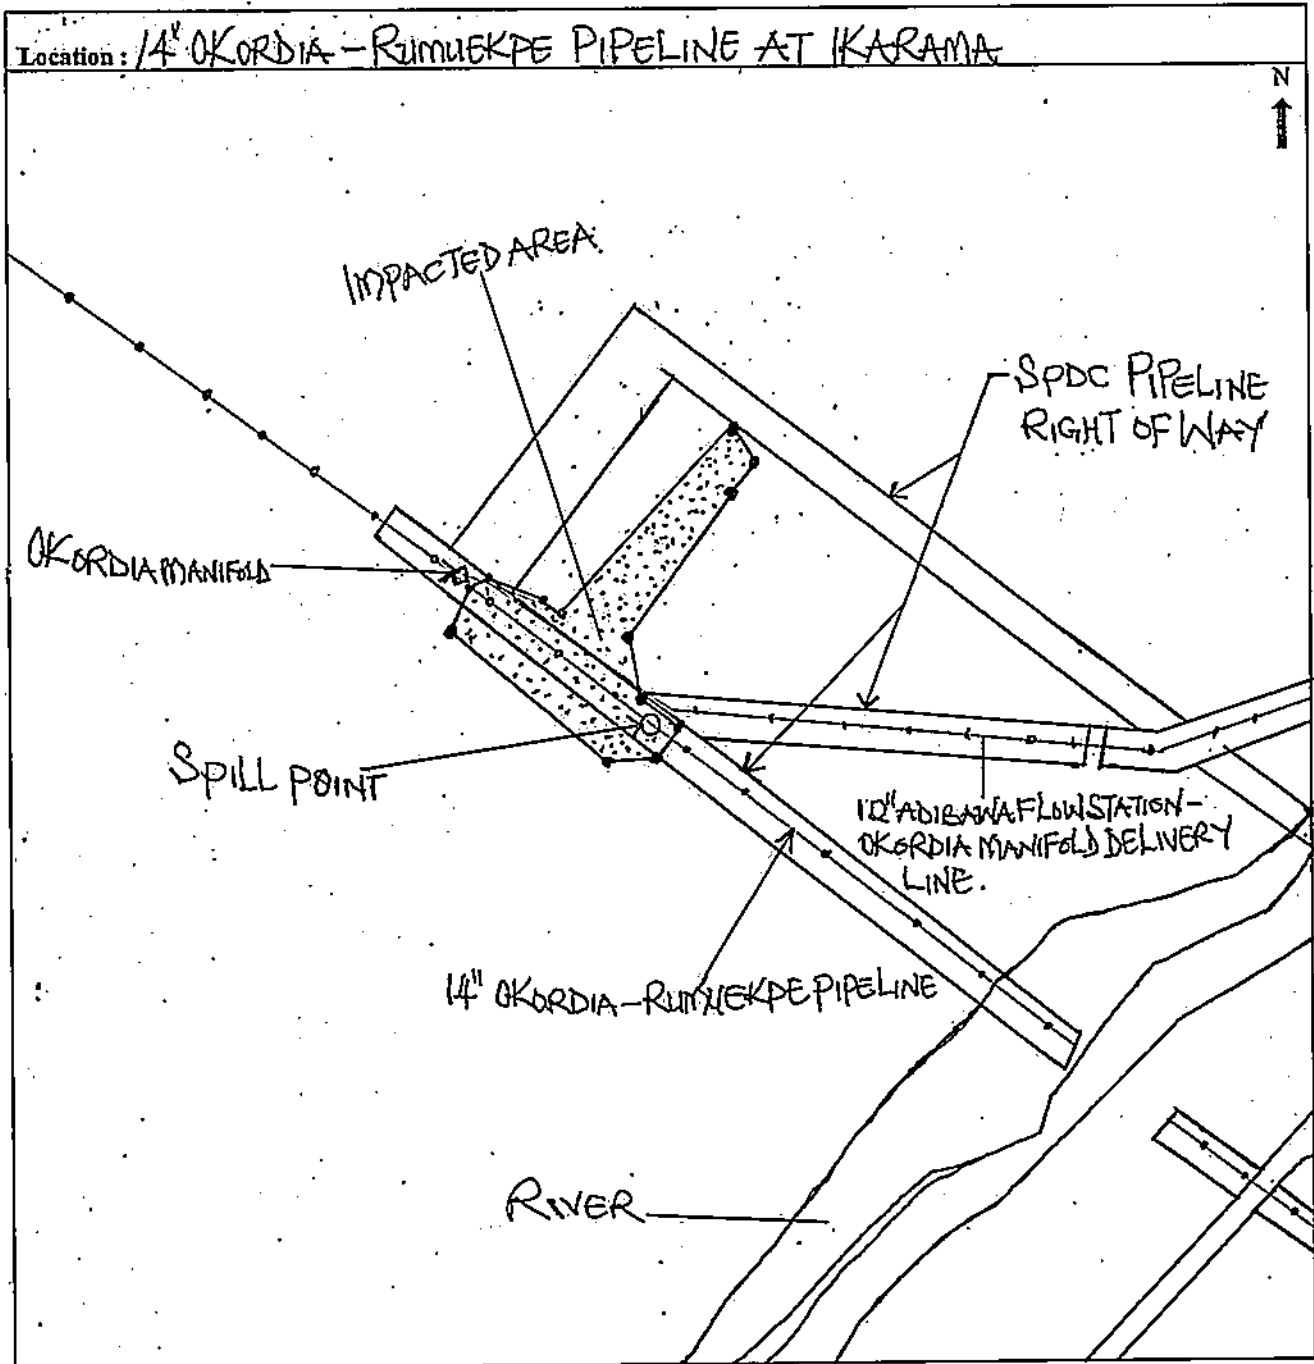
f. Appendix d: Overview sketch of the site

- Total calculated area of impact 0.63 ha
- Impact within SPDC R.O.W. YES
- Impact outside SPDC R.O.W. YES
