JOINT INVESTIGATION REPORT

INCIDENT NO: 2488941 JIV report S/N: 1030150

1. Fountain Incident Number: 2488941 2. Type of incident* OIL SPILL/FIRE
3. Name of Location 14th OKORDIA - RUMUEKPE PIPELINE
4. Name of nearest community OSHIE 5. State: RIVERS 6. LGA AHOADA WEST
7. Type of Production facility/Installation OIL PIPELINE
8. Asset owner/District THE SHELL PETROLEUM DEVELOPMENT COMPANY OF NIGERIA LTD (SPDC)/PIPELINE

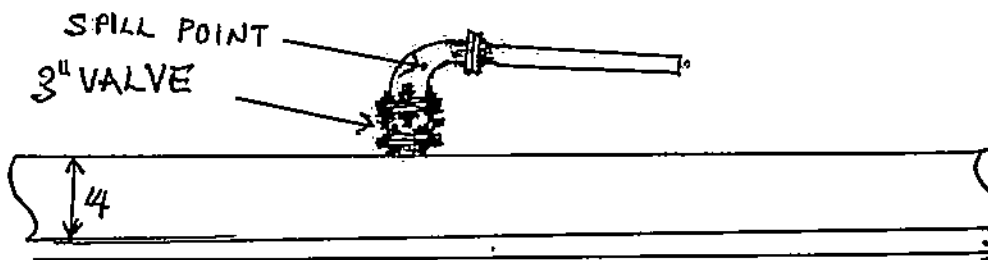
A SECTION OF 14" OKORDIA - RUMUEKPE PIPELINE AT OSHIE SHOWING CRUDE THEFT 3" VALVE INSTALLED AT 12 O'CLOCK POSITION AND A 10MM DRILL HOLE LEAK POINT ON THE ILLEGAL CONNECTION BY UNKNOWN PERSONS

LEAK REPAIR BY CLAMPING
