JOINT INVESTIGATION REPORT

INCIDENT NO: 2493947 JIV report S/N: 1030165

1. Fountain Incident Number: 2493947 2. Type of incident* OIL SPILL
3. Name of Location 24" BOMU - BONNY PIPELINE
4. Name of nearest community OWOKIRI 5. State: RIVERS 6. LGA ANDONI
7. Type of Production facility/Installation OIL PIPELINE
8. Asset owner/District THE SHELL PETROLEUM DEVELOPMENT COMPANY OF NIGERIA LTD (SPDC)/PIPELINE

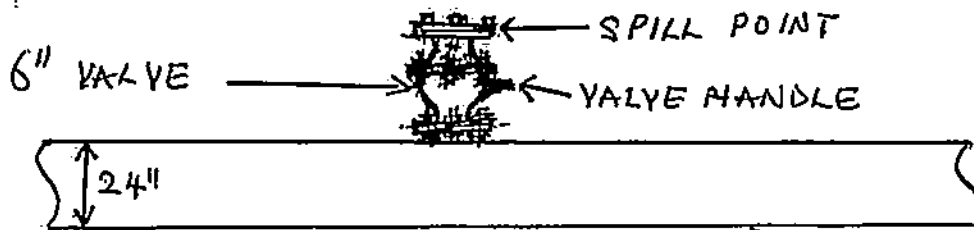
| <input checked="" type="checkbox"/> Crude oil theft (illegal bunkering) point, | <input type="checkbox"/> Saver-pit over flow | <input type="checkbox"/> Third party tampering with Clamp |

E. GRAPHIC DESCRIPTION OF LEAK POINT (while detail report of the leak point should be contained in the leak report, overview sketch of the site should be added as an appendix I) A SECTION OF 24" BOMU - BONNY PIPELINE AT OWOIKIRI SHOWING 6" VALVE CRUDE THEFT POINT INSTALLED AT 12 O'CLOCK POSITION BY UNKNOWN PERSON(S)

BLIND FLANGING
