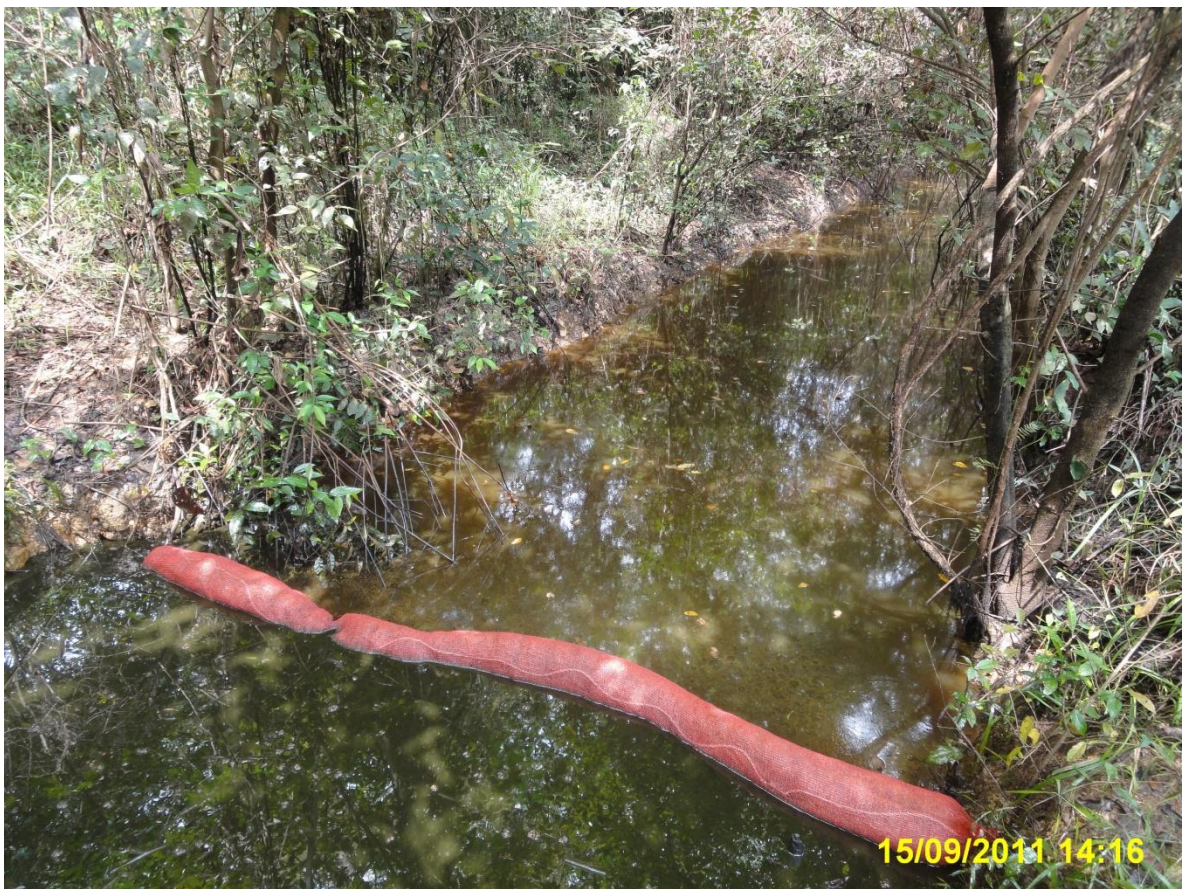
Overview: Part of spill impact on Adibawa Well 10S flowline route at Edagberi. Picture was taken during Joint Investigation of 15th September, 2011.

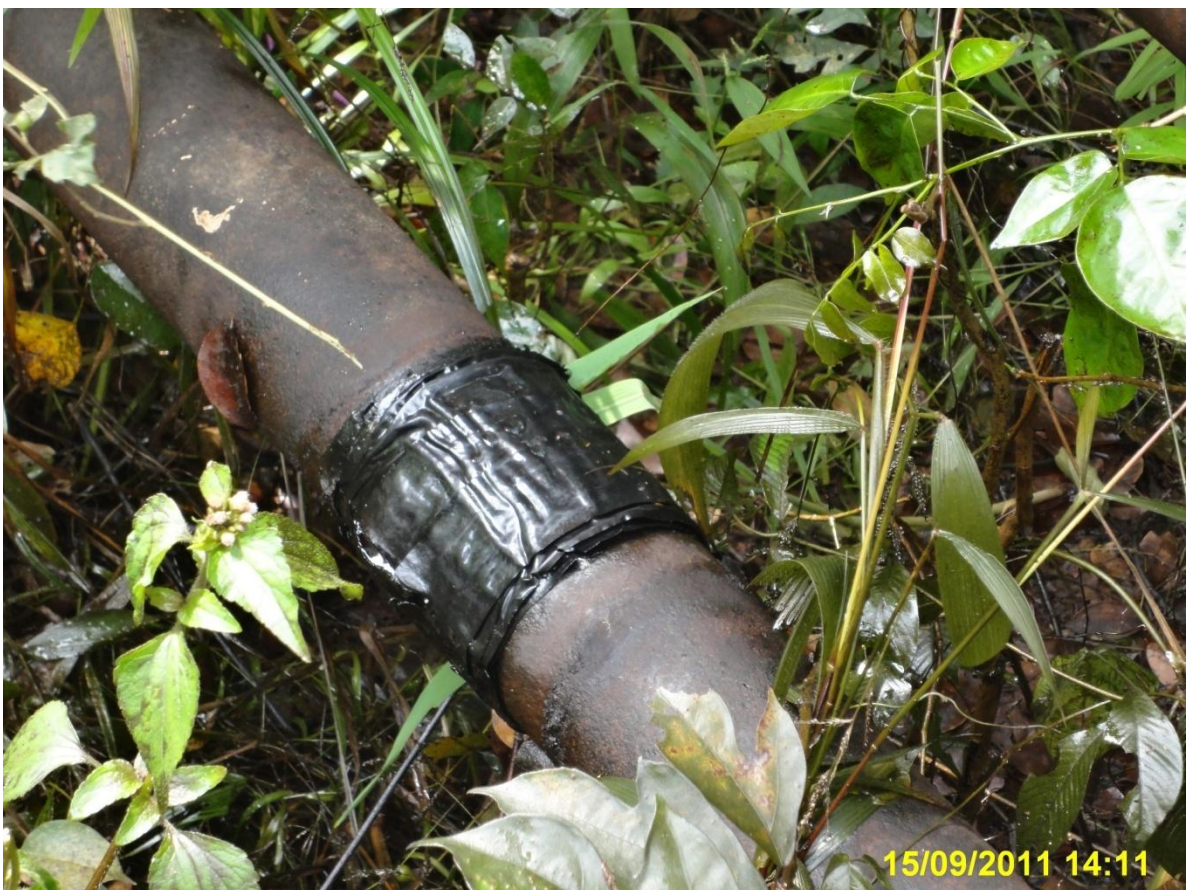
Close-up: Spill point on Adibawa Well 10S flowline at Edagberi. Picture was taken during Joint Investigation of 15th September, 2011.

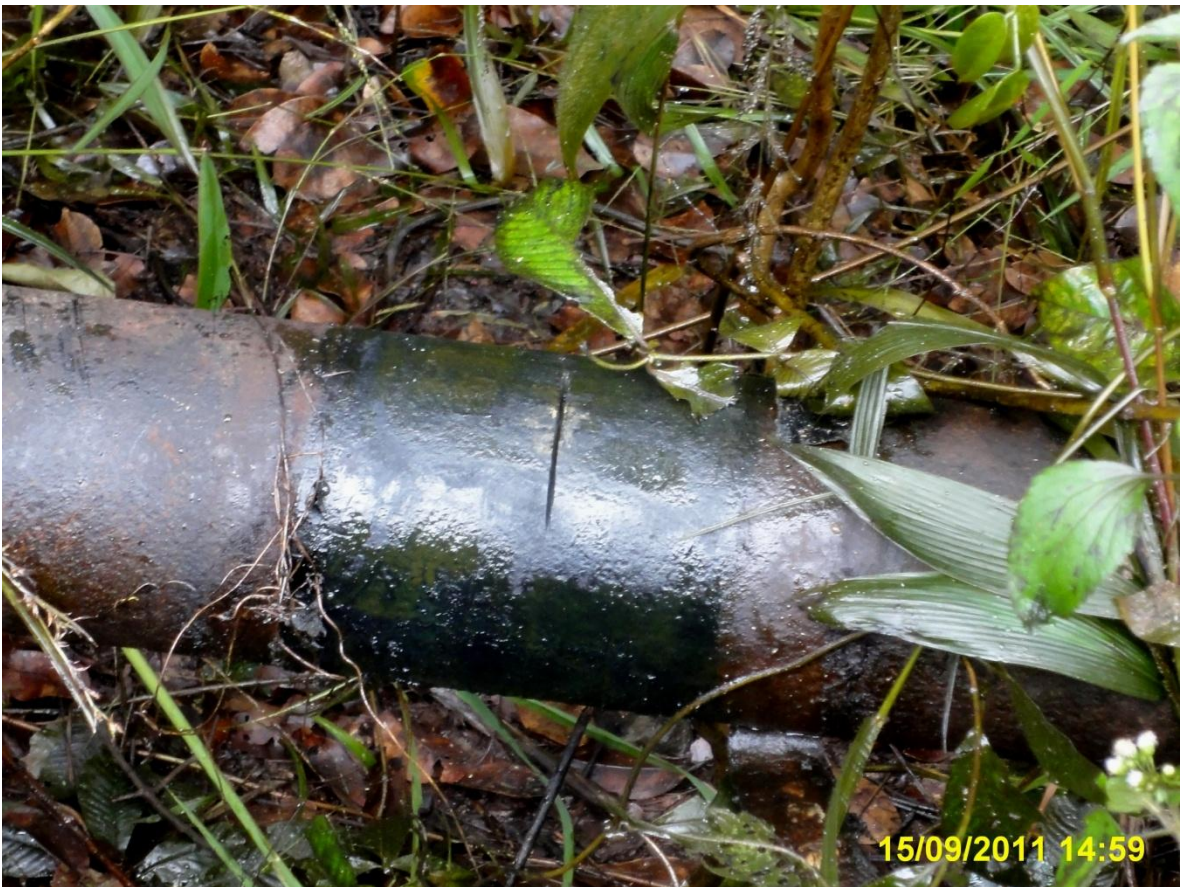
Overview: Initial hacksaw cut previously clamped on Adibawa Well 10S flowline at Edagberi.
Picture was taken during Joint Investigation of 15th September, 2011.
