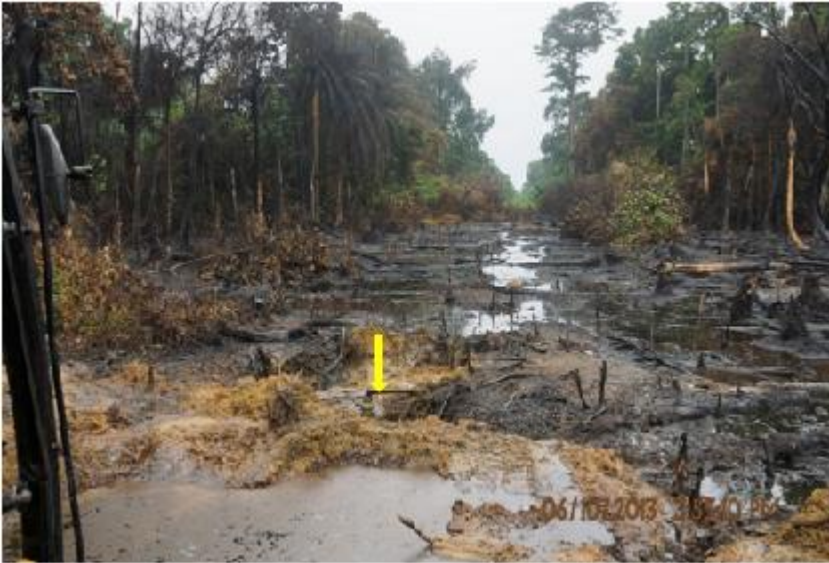
Overview: Part of spill point 1 impact on 20" Otumara Escravos Pipeline at Ajudaibo. Picture was taken during Joint Investigation of 6th October 2013.

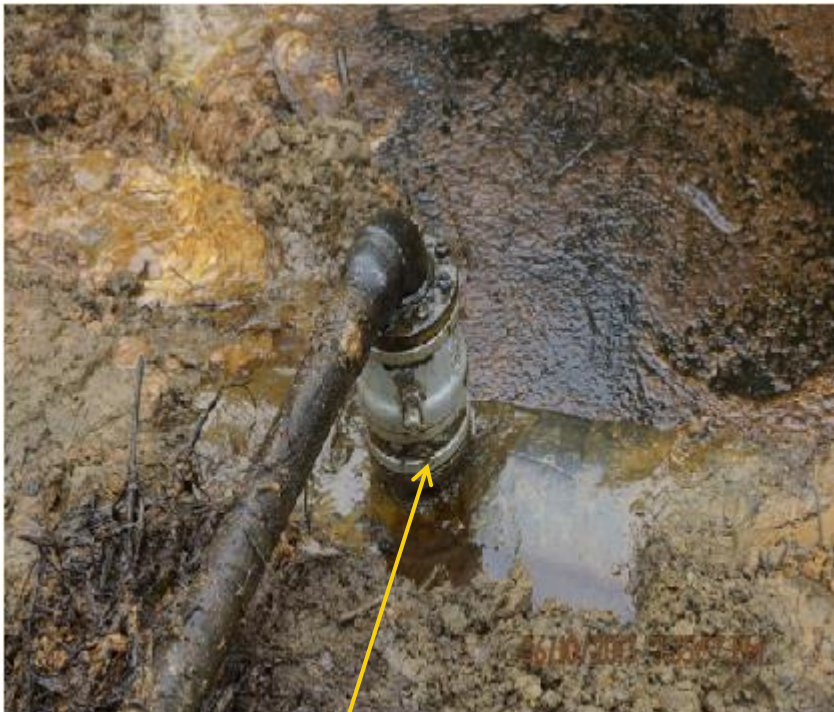
Close up: Spill point 1 due to illegal fitting 20" Otumara Escravos Pipeline at Ajudaibo. Picture was taken during Joint Investigation of 6th October 2013..

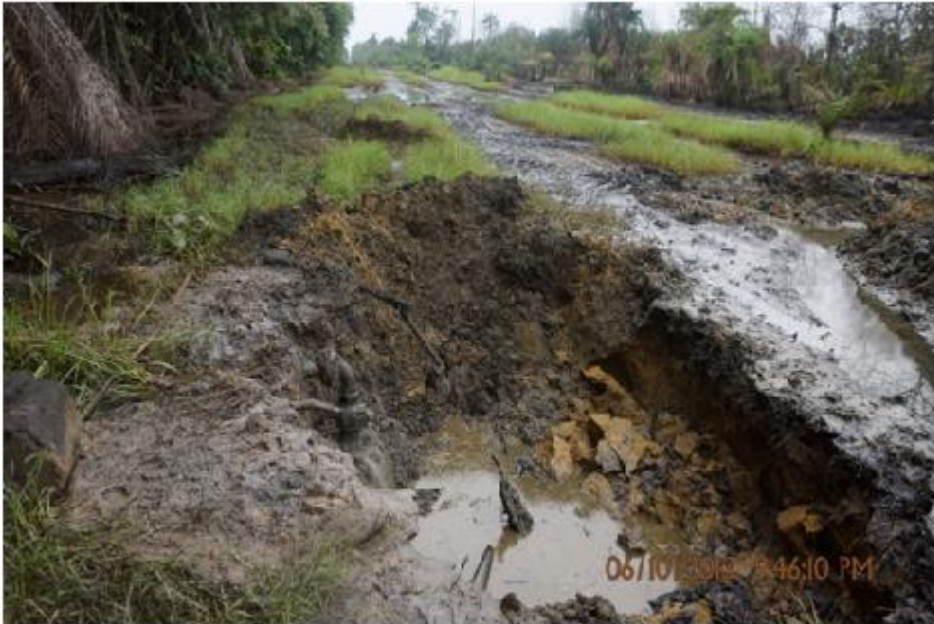
Overview: Part of spill point 1 impact on 20" Otumara Escravos Pipeline at Ajudaibo. Picture was taken during Joint Investigation of 6th October 2013.

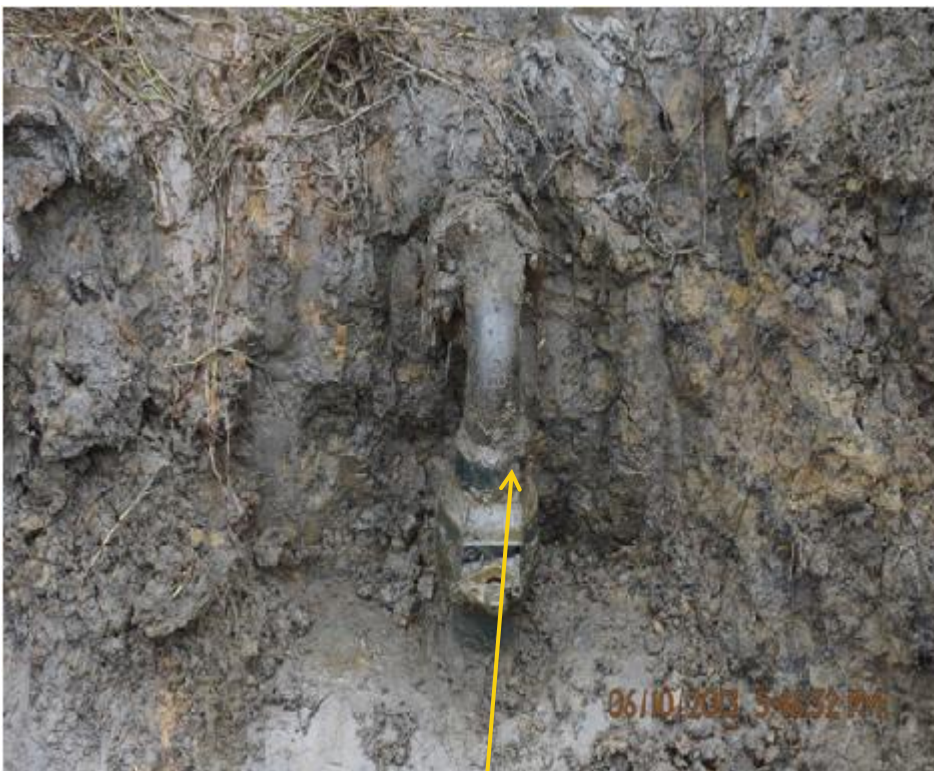
Close up: Spill point 2 - due to illegal fitting 20" Otumara Escravos Pipeline at Ajudaibo. Picture was taken during Joint Investigation of 6th October 2013.
