JOINT INVESTIGATION REPORT

INCIDENT NO: 1484078 JIV report S/N: Nº 0000059

1. Spill incident Number: 1484078 2. Type of incident* OIL SPILL
3. Name of Location 20" Rummekepe - Nkpoku PIPELINE
4. Name of nearest community OMUKPOBU 5. State: RIVERS 6. LGA EMOHUA
7. Type of Production facility/Installation OIL PIPELINE
8. Asset owner/District SPDC / PIPELINE

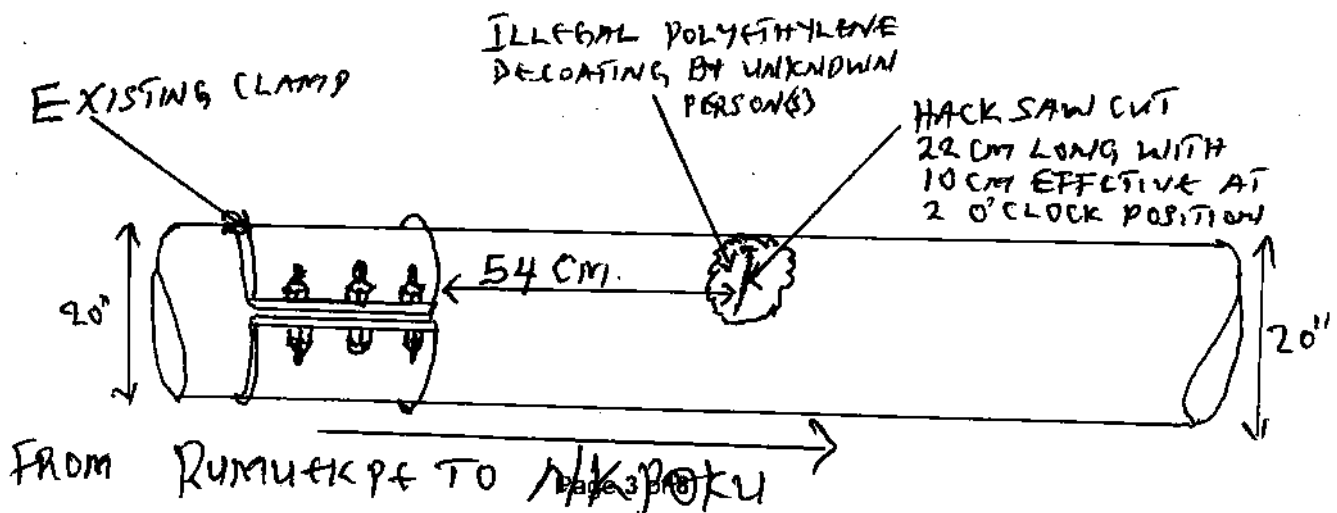
JOINT INVESTIGATION TEAM OBSERVED THAT THE CONTAINMENT EARTH BUND WALL AROUND THE SPILL POINT WAS BROKEN BY UNKNOWN PERSON(S) TO APPARENTLY AID THE SPREAD OF CRUDE OIL TO THE ENVIRONMENT

| <input type="checkbox"/> Drilled hole | <input checked="" type="checkbox"/> Hack saw cut | <input type="checkbox"/> Tear (_____). |

SECTION OF 20" RUMUKPE - NKPOKU PIPELINE AS OBUKPOBU IBRA SITUATING POSITION OF HACK SAW CUT (LEAK POINT) AT 2 O'CLOCK POSITION.

REPAIR ON THE AFFECTED SECTION OF PIPELINE WAS DONE BY CLAMPING.

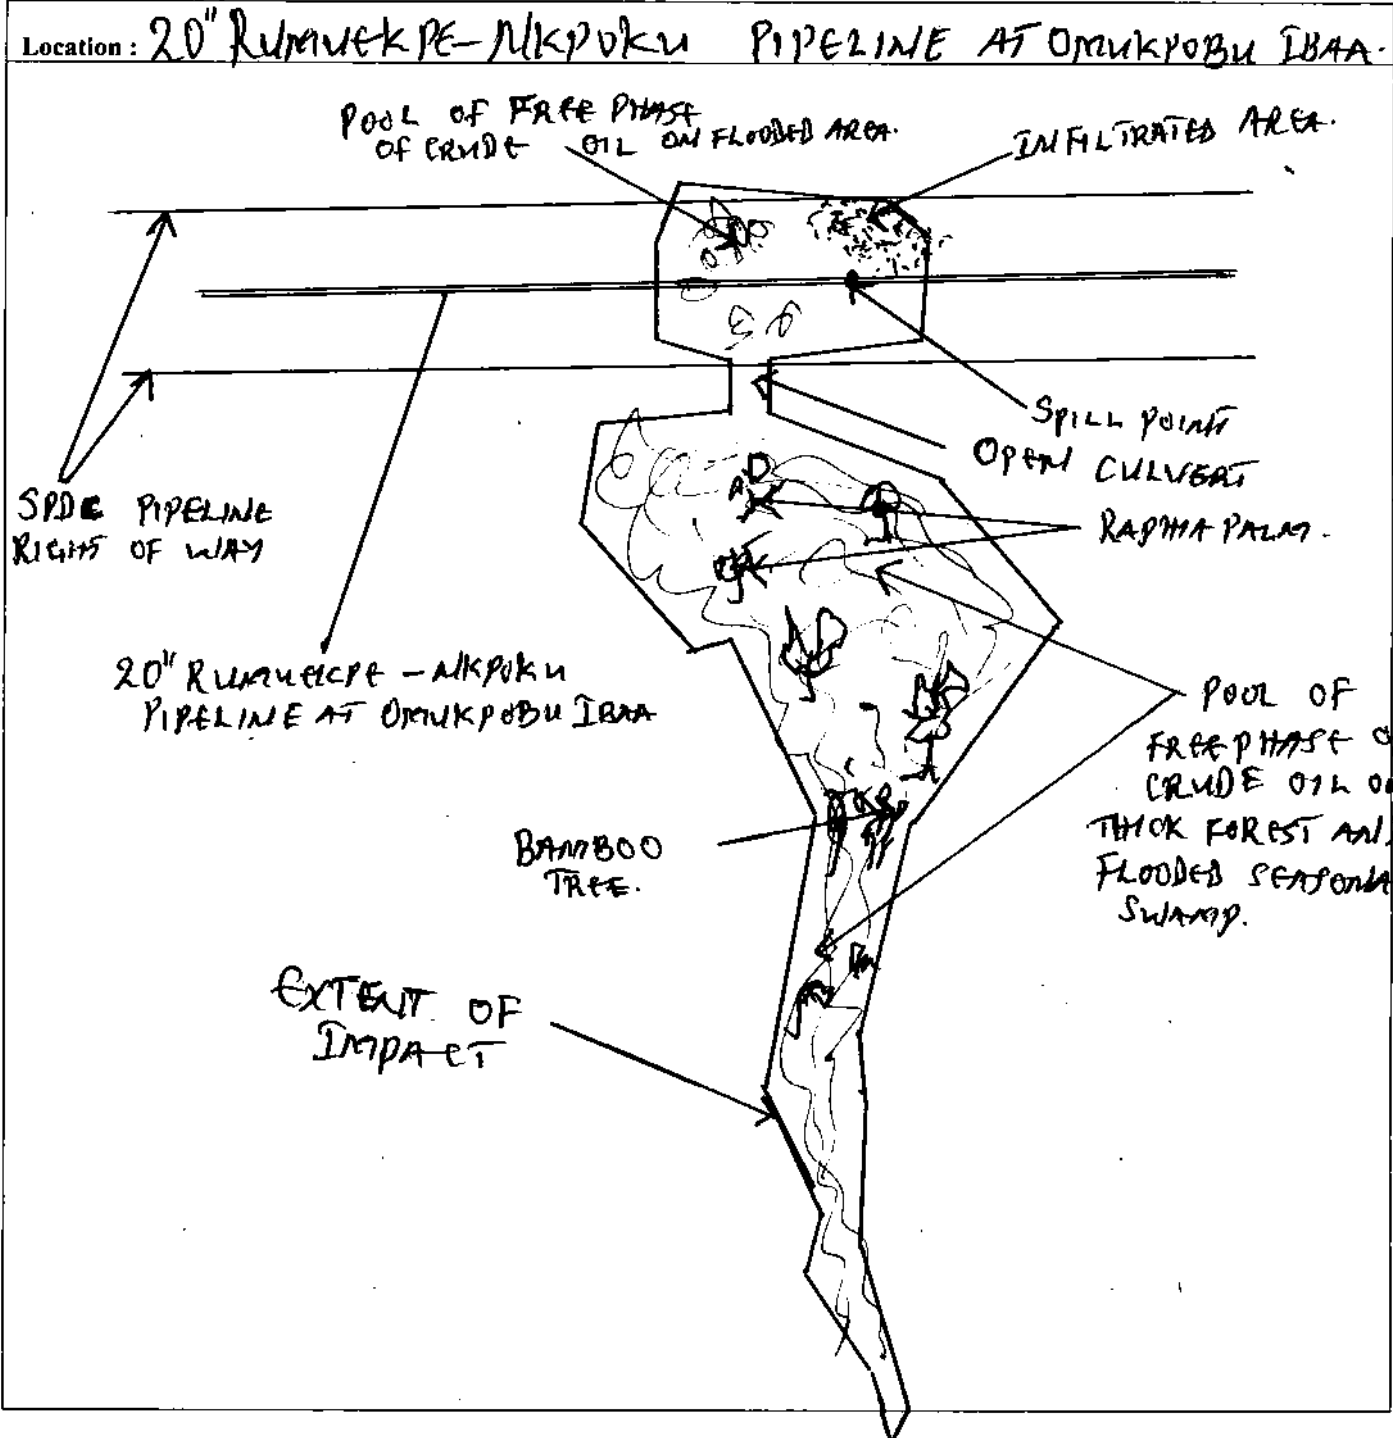
f. Appendix 1: Overview sketch of the site

- Total calculated area of impact 5.38 Ha
- Impact within R.O.W YES
- Impact outside R.O.W YES
