JOINT INVESTIGATION REPORT

INCIDENT NO: 2723595 JIV report S/N:

1. Fountain Incident Number: 2723595 2. Type of incident* OIL SPILL
3. Name of Location 24" NIKPOKU - BOMU PIPELINE
4. Name of nearest community AGBETA 5. State: RIVERS 6. LGA ELEME
7. Production Facility/Installation CRUDE OIL PIPELINE
8. Asset Owner/Hub THE SHELL PETROLEUM DEVELOPMENT COMPANY
OF NIGERIA LIMITED / PIPELINE

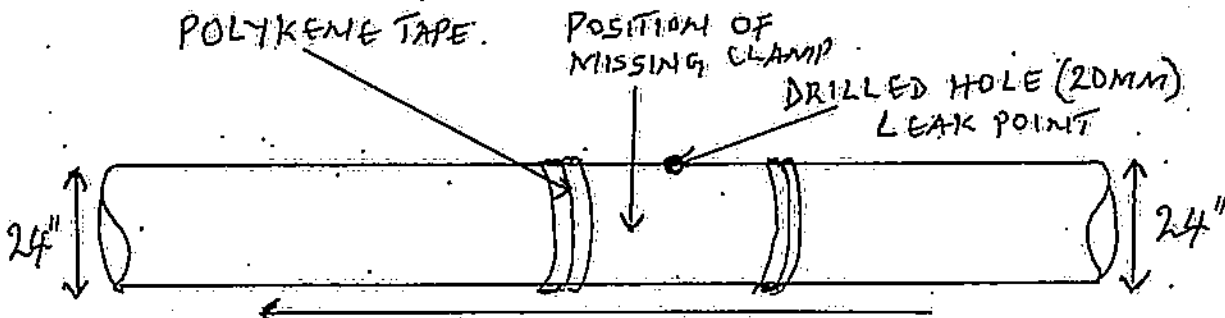
| <input checked="" type="checkbox"/> Smooth round-edge hole <u><DRILLED></u> | <input type="checkbox"/> Rough-edge hole | <input type="checkbox"/> Hack saw cut |
| <input checked="" type="checkbox"/> Others (specify) <u>MISSING CLAMP</u> | | |

SECTION OF 24" NKPOLU - BOMU PIPELINE AT AGBETA SHOWING POSITION OF MISSING CLAMP AND DRILLED HOLE AT 12 O'CLOCK POSITION.

RECOVERY COMPLETED. REPAIR WAS DONE BY CLAMPING.
