# JOINT INVESTIGATION REPORT

INCIDENT NO: 2725259 JIV report S/N: 0683

1. Fountain Incident Number: 2725259 2. Type of incident\* OIL SPILL  
3. Name of Location 12" MORNER 2 - OGALE PIPELINE  
4. Name of nearest community ODAGWA 5. State: RIVERS 6. LGA ETCHE  
7. Production Facility/Installation CRUDE OIL PIPELINE  
8. Asset Owner/Hub THE SHELL PETROLEUM DEVELOPMENT COMPANY  
OF NIGERIA LIMITED / PIPELINE

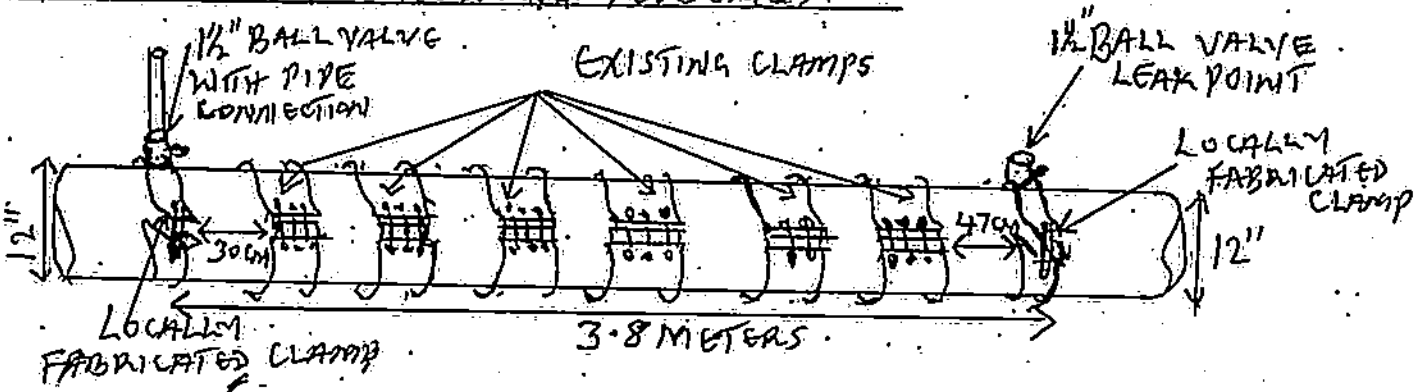
| <input checked="" type="checkbox"/> Crude oil theft (illegal bunkering) point, | <input type="checkbox"/> Saver-pit over flow | <input type="checkbox"/> Third party tampering with Clamp |

- Third party interference (Sabotage ; crude theft ; Line theft ; Accidental 3<sup>rd</sup> party damage   
 Operational  Others (including Mystery spills) \_\_\_\_\_

SECTION OF 12" IMPROVED 2-OGALE PIPELINE AT ODAGWA SHOWING TWO NOS OF CRUDE OIL THEFT POINTS INSTALLED AT 12 O'CLOCK POSITION BY UNKNOWN PERSONS.

CRUDE OIL RECOVERY AND REPAIR ACTIVITIES ARE ONGOING.
