JOINT INVESTIGATION REPORT

INCIDENT NO: 2728324 JIV report S/N:

1. Fountain Incident Number: 2728324 2. Type of incident: OIL SPILL
3. Name of Location: 8" AGBADA 2 - NKPOKU DELIVERY LINE
4. Name of nearest community: OMUONHA-IGHURUIA State: RIVERS 6. LGA: IKWERRE
7. Production Facility/Installation: OIL PIPELINE
8. Asset Owner/Hub: THE SHELL PETROLEUM DEVELOPMENT COMPANY OF NIGERIA LIMITED (SPDC)/PIPELINE

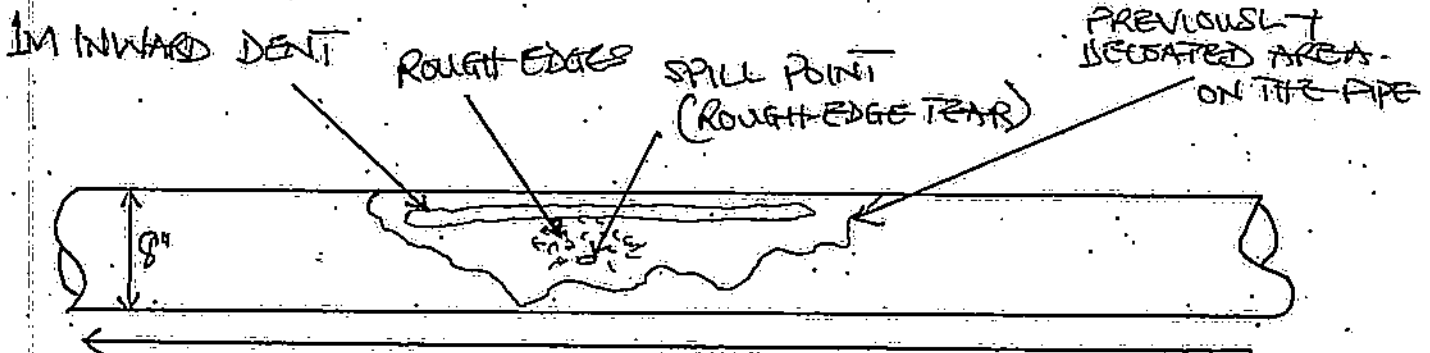
| <input checked="" type="checkbox"/> Tear (<u>ROUGH-EDGE</u>) | | |

E. GRAPHIC DESCRIPTION OF LEAK POINT (while detailed description of the leak point should be contained in the leak report, overview sketch of the site should be added as appendix 1) A SECTION OF 8" AGBADA 2-NKPOKU DELIVERY LINE AT OMUJHA-IGWURUA SHOWING A ROUGH-EDGE TEAR AT 9 O'CLOCK POSITION CAUSED BY ACCIDENTAL 3RD PARTY DAMAGE BY UNKNOWN PERSON(S)

REPAIR BY CLAMPING ONGOING
