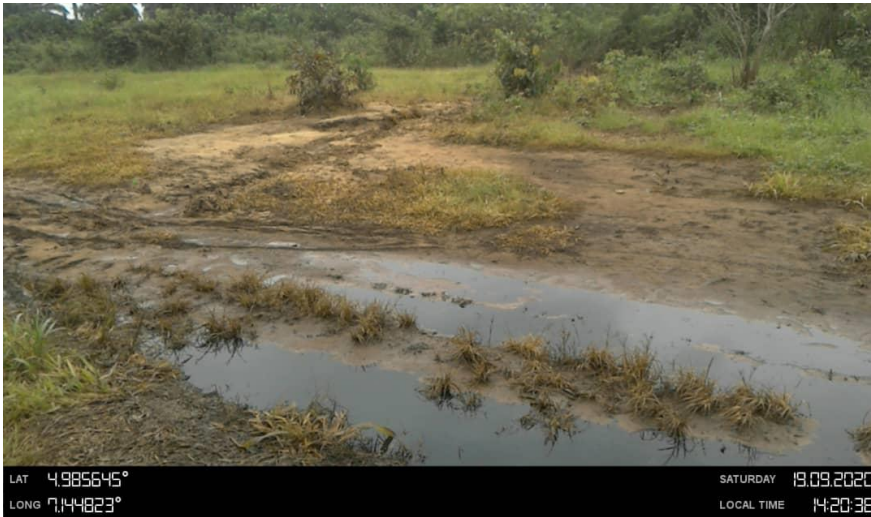
Overview: Part of spill impact on 8" Nkali - Imo River2 Delivery line at Muanyimochi-Odagwa. Picture was taken during Joint Investigation on 19th September 2020.

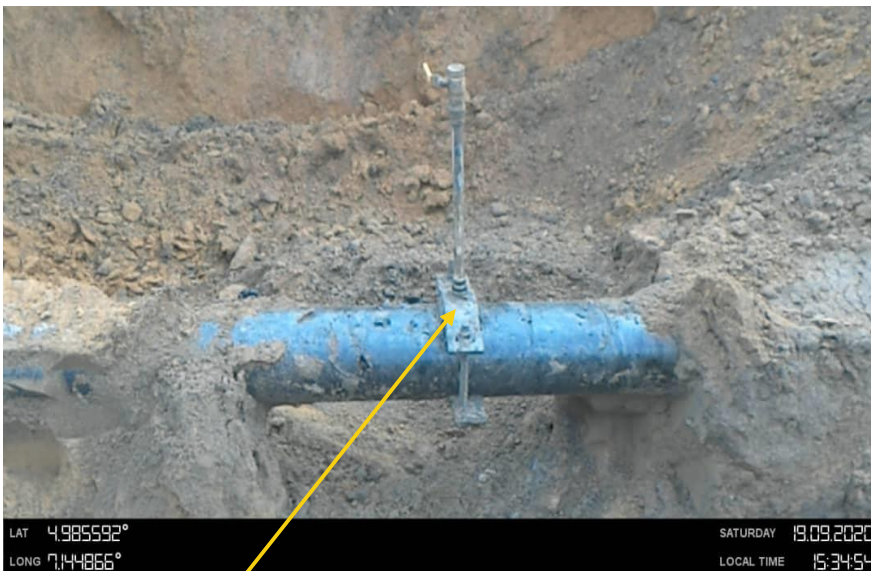
Close-up: Crude oil theft point installed at 9 o'clock position on 8" Nkali - Imo River2 Delivery line at Muanyimochi-Odagwa. Picture was taken during Joint Investigation on 19th September 2020.
