# JOINT INVESTIGATION REPORT

INCIDENT NO: 2741054 JIV report S/N:

1. Fountain Incident Number: 2741054 2. Type of incident: OIL SPILL  
3. Name of Location: 16" EGBEMA - ASSA PIPELINE  
4. Name of nearest community: EKPEAGA 5. State: RIVERS 6. LGA: OGBA EGBEMA  
7. Production Facility/Installation: CRUDE OIL PIPELINE  
8. Asset Owner/Hub: THE SHELL PETROLEUM DEVELOPMENT COMPANY  
OF NIGERIA LIMITED / PIPELINE

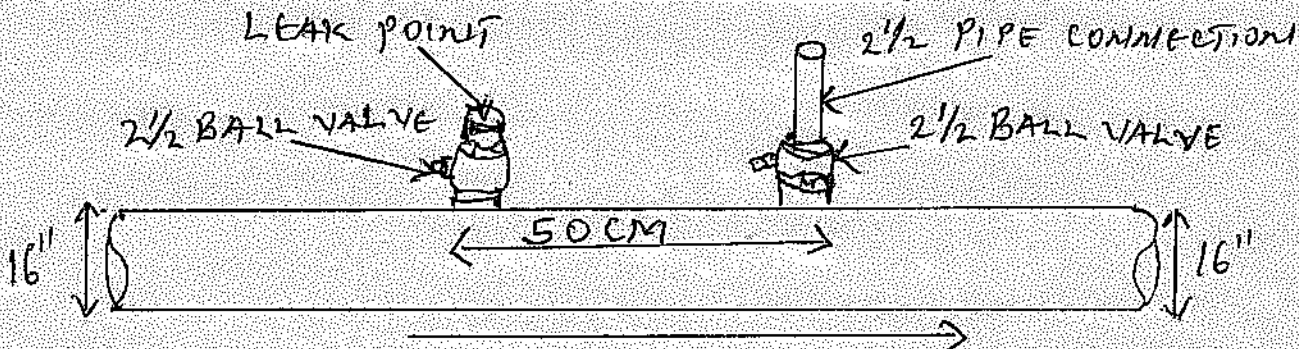
| <input checked="" type="checkbox"/> Crude oil theft (illegal bunkering) point, | <input type="checkbox"/> Saver-pit over flow | <input type="checkbox"/> Third party tampering with Clamp |

SECTION OF 16" EGBEMA - ASSA PIPELINE AT EKPEAGA SHOWING 2 NOS OF CRUDE OIL THEFTS POINTS INSTALLED AT 12 O'CLOCK POSITION BY UNIDENTIFIED PERSON(S).

REPAIR WORK COMPLETED.
